March 25-29, 1985 / Sheraton Hotel
Hynes Auditorium / Boston, Massachusetts

FIELD EXPERIENCE WITH ENGINEERING MATERIALS IN INDUSTRIAL HEAT RECOVERY SYSTEMS

M. F. Rothman
Cabot Corporation
1020 West Park Avenue
Kokomo, Indiana 46901

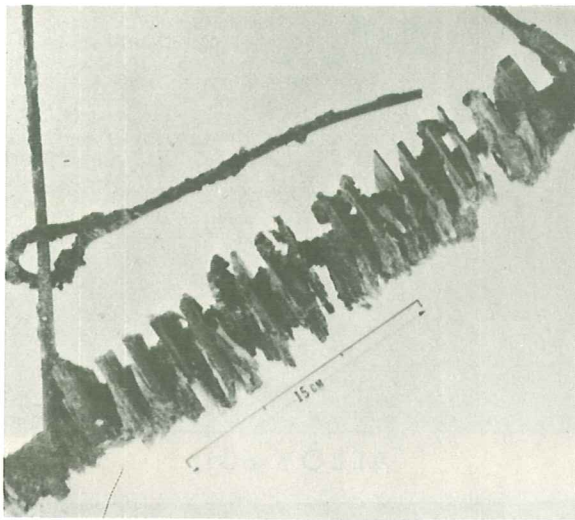
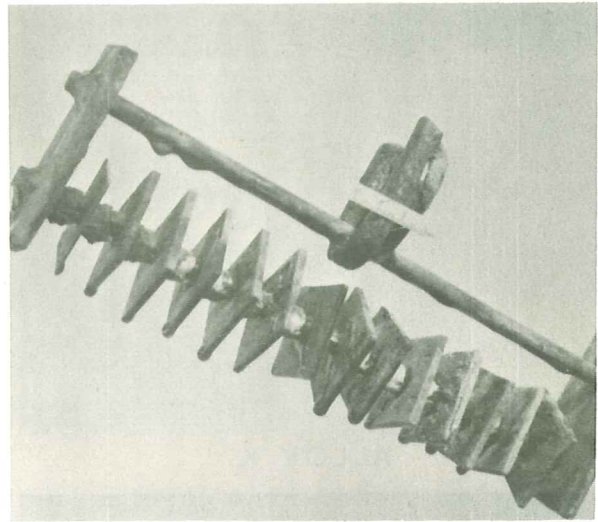
It is obvious from the appearance of the racks that they were exposed to different conditions. Rack No. 1 had crusty deposits which were apparently solid at the exposure temperature, while the deposits on Rack No. 2 were clearly liquid, as evidenced by the frozen droplets at the bottom corners of some of the coupons. This factor, in addition to the variation in glass composition, could certainly be expected to produce a difference in specific alloy corrosion behavior.

FIGURE 1: APPEARANCE OF TEST RACKS EXPOSED IN A FIBERGLASS MELTING FURNACE RECUPERATOR WITH TWO DIFFERENT GLASS FORMULATIONS.

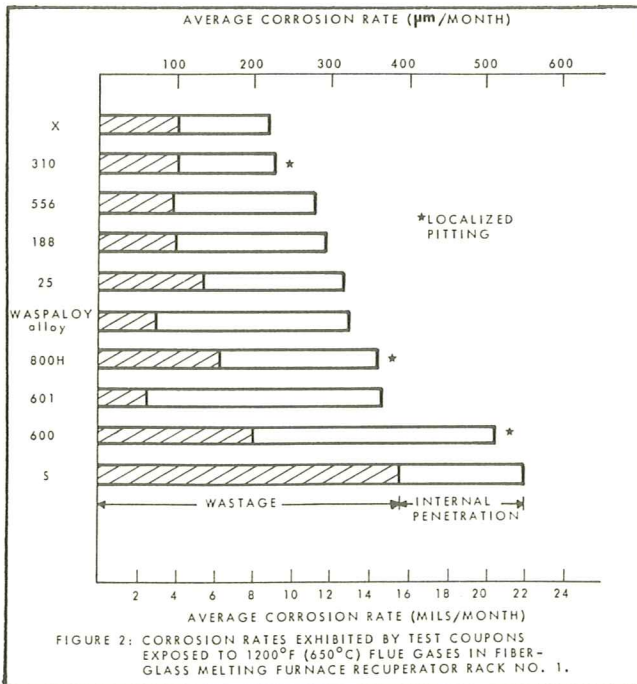
Results of the evaluation of alloy corrosion behavior obtained from the two test racks are presented in Figures 2 and 3. In the case of Rack No. 1, the typical attack observed involved oxidation combined with mild sulfidation. From an examination of Figure 2, it is evident that the high nickel and low chromium materials such as alloy S (67% Ni, 16% Cr) and alloy 600 (74% Ni, 16% Cr) were most severely attacked. The higher iron and chromium materials like alloy 601 (61% Ni, 14% Fe, 22% Cr) and alloy 800H (33% Ni, 44% Fe, 21% Cr) fared only a little better. The materials most resistant to uniform corrosion

were alloy X (47% Ni, 19% Fe, 22% Cr) and 310 stainless steel (20% Ni, 51% Fe, 25% Cr), although the 310 stainless did exhibit appreciable localized pitting.

The poor behavior of the high nickel and high nickel plus iron alloys would be expected under a corrosion mode dominated by high-temperature sulfidation. This is consistent with the laboratory studies performed by Lai⁽⁶⁾. The superior performance of alloy X with its high nickel plus iron content is unexplained in this case, however, since its resistance to sulfidation as determined by Lai is no better than that of the alloys previously mentioned, including alloy 601. Nevertheless, the role of subsurface sulfide formation in the corrosion of the high nickel alloys like alloy 601 has been confirmed metallographically, as shown in Figure 4. It would appear that chromium depletion through sulfide formation followed by accelerated oxidation of the chromium depleted areas is a likely partial appreciation of the corrosion mechanism, but other factors such as the role of highly reactive glass vapor components containing K and Ca must surely be involved. This is supported by the SEM micrograph and associated EDAX analyses presented in Figure 5 for a sample of the cobalt-base alloy 25 chain used to support a test rack, albeit in a hotter part of the recuperator. Clearly, K and Ca are major constituents in the corrosion products.

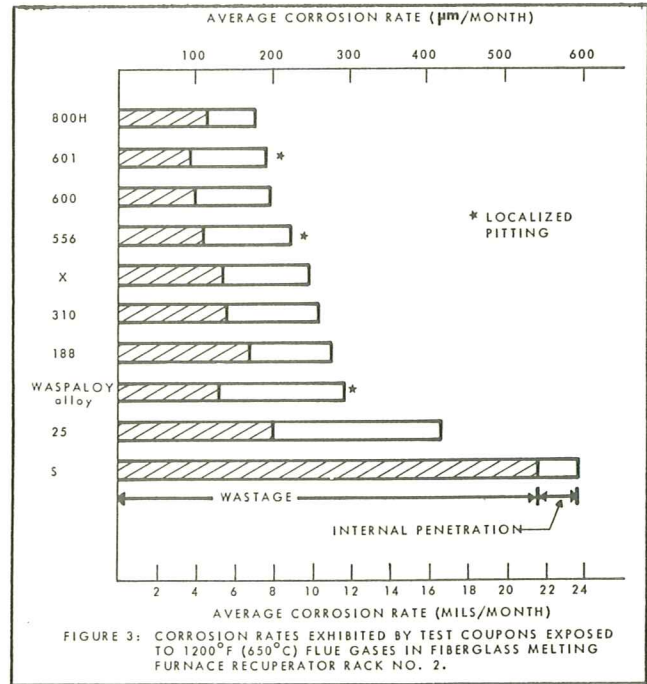
The alloy ranking for the second test rack exposed in the fiberglass melting furnace recuperator differs significantly from that obtained in the first rack exposure. As shown in Figure 3, the alloys most resistant to uniform corrosion were three of the four worst performing alloys in the first test, including alloy 601. Although this is consistent with the fact that there was no evidence of sulfidation, the more important factor is the change in the nature of the deposits from solid to liquid phase. The mode of corrosion here most likely involves molten glass fluxing of protective oxide scales with subsequent internal oxida-

Although alloy X falls in the middle group of materials in terms of these second test rack results, it is important to note that it exhibits uniform thinning. Several of the materials more resistant to uniform corrosion, including alloy 601, exhibit appreciable localized pitting. This is illustrated in Figure 6. In terms of minimum remaining unaffected metal, these alloys would rank worse than alloy X, though certainly still better than the least-resistant materials.

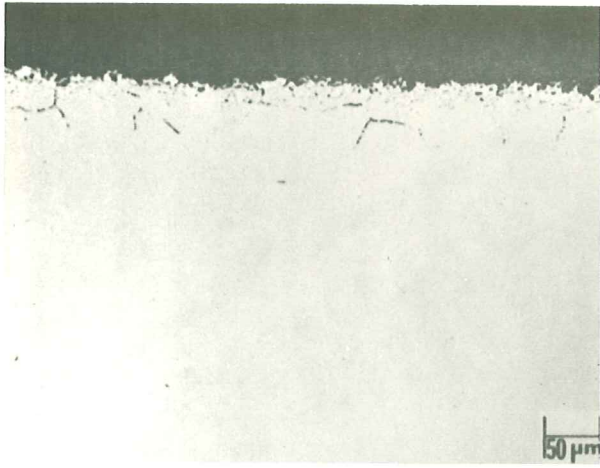
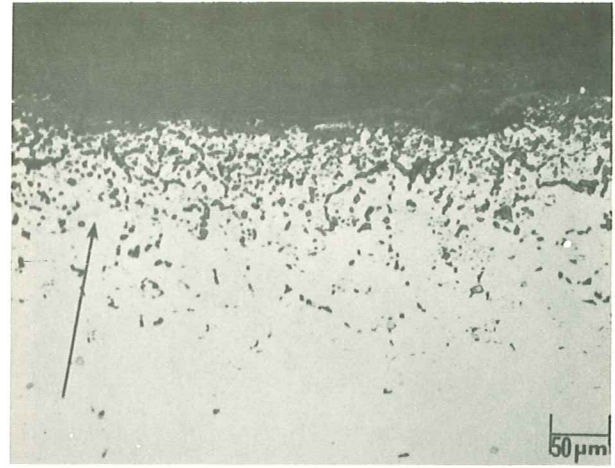
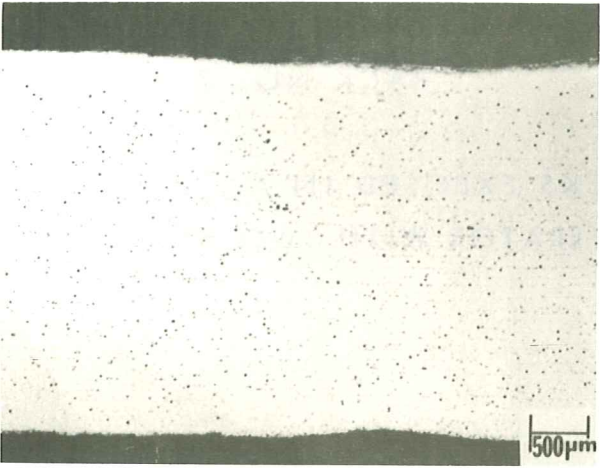
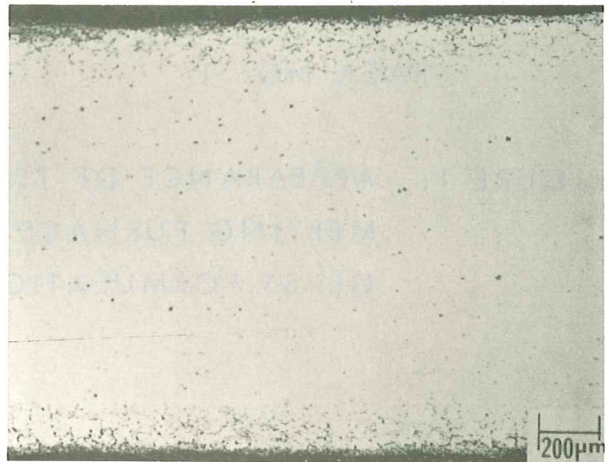
FIGURE 4: MICROSTRUCTURES FOR ALLOY X AND ALLOY 601 COUPONS EXPOSED IN FIBERGLASS MELTING FURNACE RECUPERATOR RACK NO. 1. ARROW IN ALLOY 601 MICROGRAPH INDICATES SULFIDES PRESENT. DARK PARTICLES ARE OXIDES.

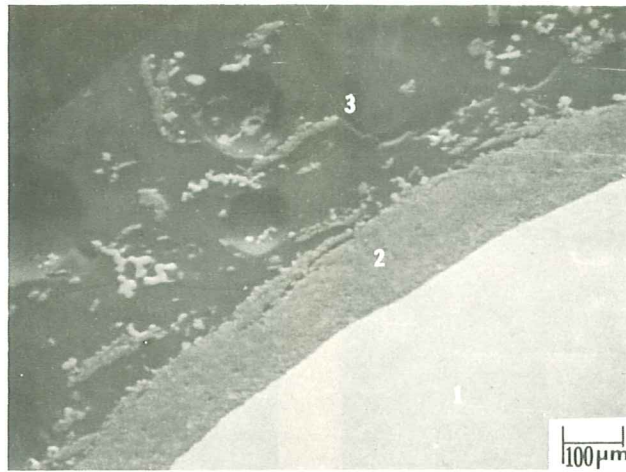
FIGURE 5: SEM THROUGH-THICKNESS MICROGRAPH OF ALLOY 25 CHAIN USED TO SUPPORT RACK IN FIBERGLASS MELTING FURNACE RECUPERATOR.

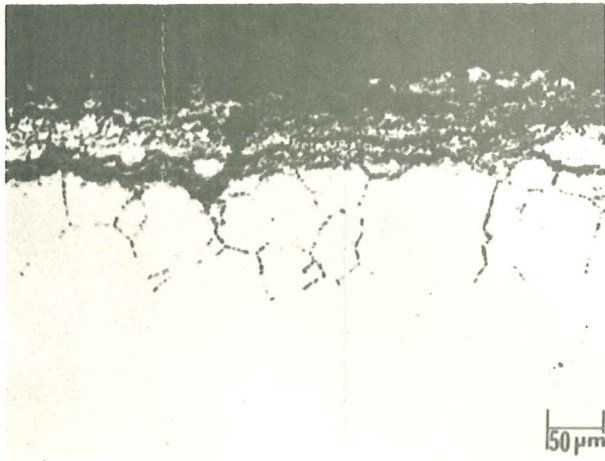
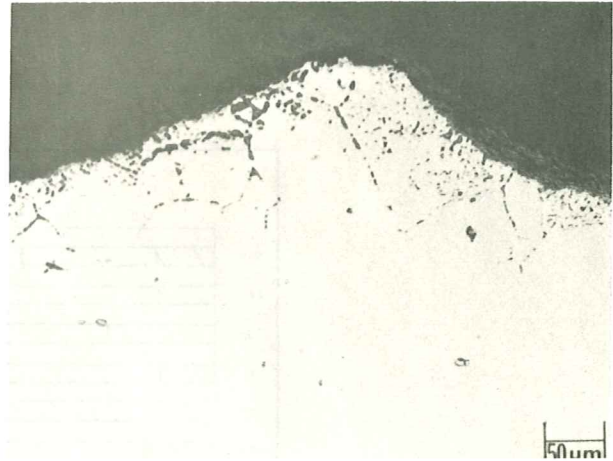
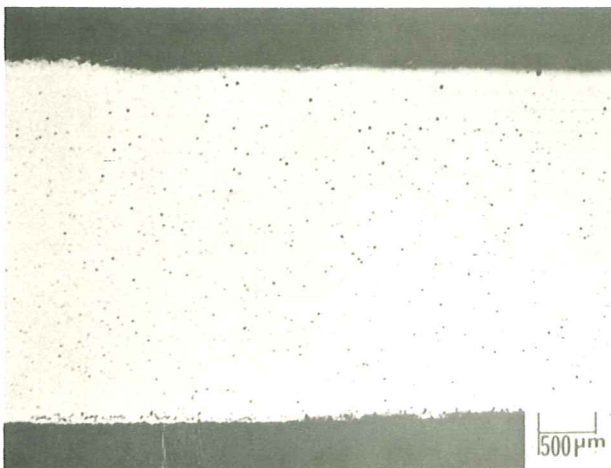
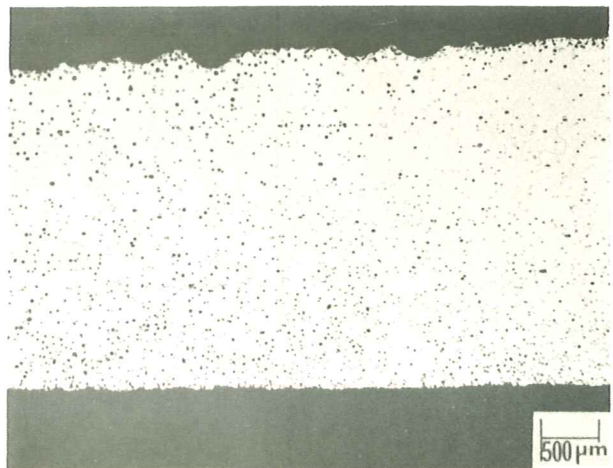
FIGURE 6: MICROSTRUCTURES FOR ALLOY X AND ALLOY 601 COUPONS EXPOSED IN FIBERGLASS MELTING FURNACE RECUPERATOR RACK NO. 2.

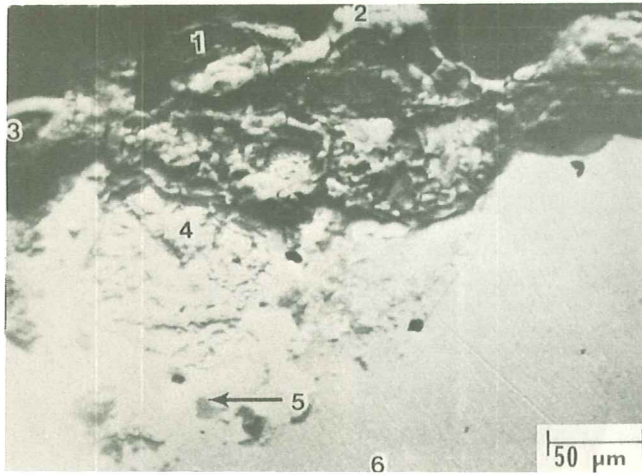
A piece of the failed tubing was sectioned and subjected to SEM EDAX semi-quantitative analysis. Typical SEM through-thickness photomicrographs and related EDAX analyses are presented in Figures 7 and 8. From an examination of Figure 7 it is clear that, despite the use of sulfur-free fluxes, sulfur is present in the surface scale as is chlorine, calcium and potassium. Small amounts of sodium, lead and even bromine were also found in other spots. The calcium- and silicon-rich particle on the surface may be from the melting furnace refractory. The other scale areas are probably mixtures of compounds such as Fe_2O_3 , FeCl_2 , KCl and K_2SO_4 . The low chromium content in these scales is consistent with the concept of surface chromium depletion by alkali-halide fluxing of chromium-bearing protective oxide scales (possibly combined with sulfidation) advanced by Russell et al.⁽⁷⁾, and also with the possible formation of volatile chromium oxychloride compounds proposed by Saunders and Schlierer⁽⁸⁾.

FIGURE 7: SEM THROUGH-THICKNESS MICROGRAPH AND SELECTED AREA EDAX SEMI-QUANTITATIVE ANALYSES FOR FAILED 12 Cr FERRITIC STAINLESS RECUPERATOR TUBE FROM A REVERBERATORY ALUMINUM SCRAP MELTING FURNACE.

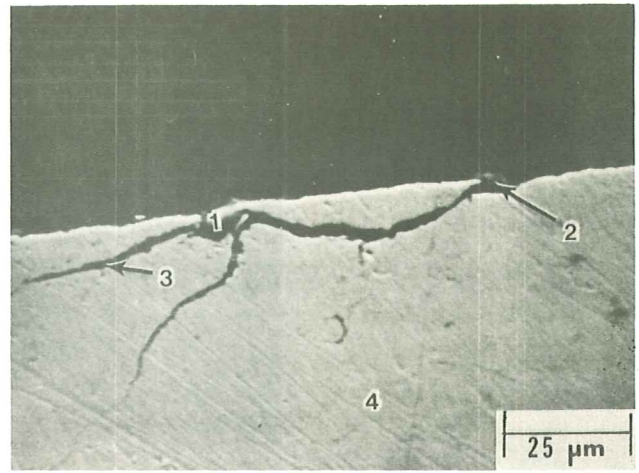
The SEM photomicrograph shown in Figure 8 reveals that general corrosion is not the only form of material degradation being experienced by the tubes of 12% Cr ferritic stainless. Internal cracks were observed which had apparently initiated at the site of glassy-looking particles on the tube surface. These particles appear once again to be basically iron-chloride/oxide mixtures with sulfur and potassium also present.

FIGURE 8: SEM THROUGH-THICKNESS MICROGRAPH AND SELECTED AREA EDAX SEMI-QUANTITATIVE ANALYSES FOR FAILED 12 Cr FERRITIC STAINLESS RECUPERATOR TUBE FROM A REVERBERATORY ALUMINUM SCRAP MELTING FURNACE.

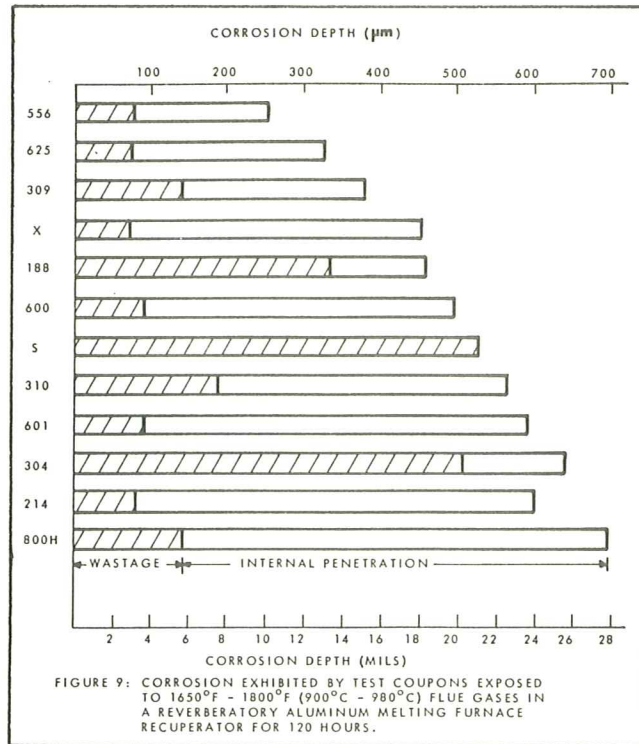
Figure 9 shows the ranking of material performance in these tests for 12 commercial alloys, and some typical through-thickness microstructures are presented in Figure 10. Despite the short duration of the exposure, the extreme aggressiveness of the environment is evidenced by the substantial amount of metal wastage and internal penetration experienced by even the best performing material, alloy 556. This severe amount of material degradation had not been expected in view of other experiences with similar "sulfur-free" environments.

The reasons for the ranking of material performance presented in Figure 9, albeit from bad to worse, are not immediately obvious. There appears to be little similarity among those materials which exhibit the most resistance and, for that matter, among those which exhibit the least resistance. The aluminum-oxide-forming alloy 214 appears to behave little different from the chromia-forming alloys. Iron-base, nickel-base and cobalt-base alloys exhibit no particular distinctiveness. High refractory element content alloys such as alloy 188 and alloy S exhibit perhaps an increased amount of metal loss, but no more than 304 stainless steel, which has no refractory element content. HASTELLOY alloy X, by the same token, has 9% molybdenum and exhibits the least metal loss of the alloys tested.

FIGURE 9: CORROSION EXHIBITED BY TEST COUPONS EXPOSED TO 1650°F - 1800°F (900°C - 980°C) FLUE GASES IN A REVERBERATORY ALUMINUM MELTING FURNACE RECUPERATOR FOR 120 HOURS.

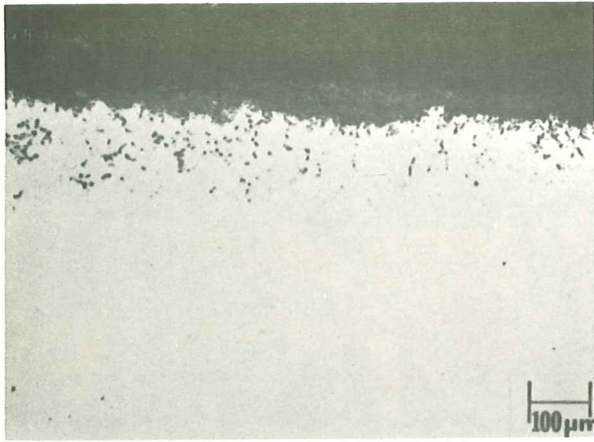
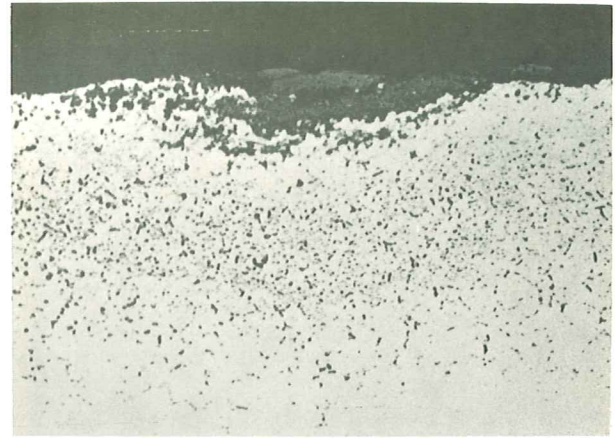
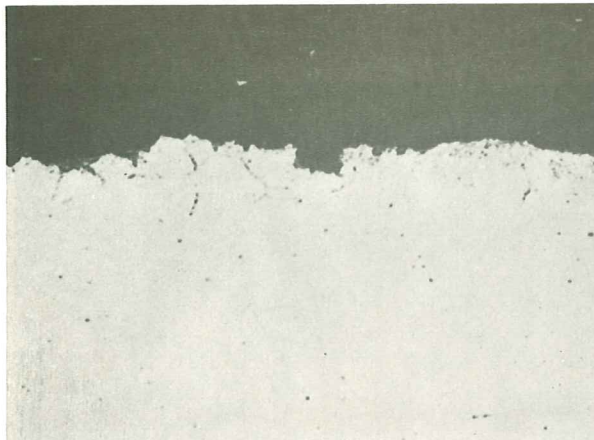
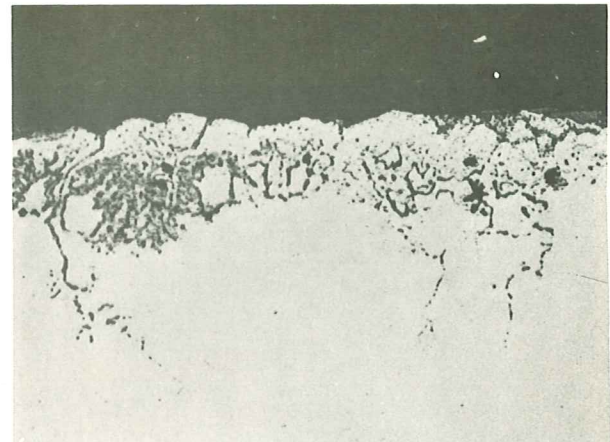
FIGURE 10: MICROSTRUCTURES OF VARIOUS ALLOY COUPONS EXPOSED IN THE REVERBERATORY ALUMINUM MELTING FURNACE RECUPERATOR.

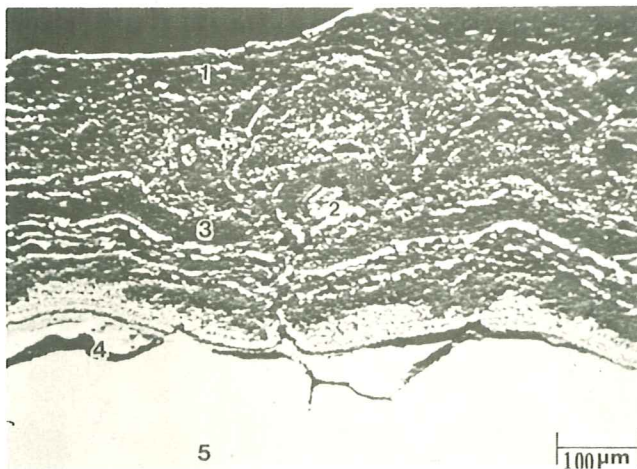
Suspecting that the environment might contain sulfur or other contaminants despite the claims of the flux suppliers, chemical analyses for the different flux components was performed. It was determined that the various flux components did, in fact, contain up to as much as 2.1% sulfur. Such contamination would serve to explain the results illustrated in Figure 11, in which an SEM photograph of the scale formed upon the 304 stainless steel coupon is shown together with EDAX analyses of various areas. The presence of a heavy concentration of sulfur at the scale/metal interface is clearly revealed.

FIGURE 11: SEM THROUGH-THICKNESS MICROGRAPH AND SELECTED AREA EDAX SEMI-QUANTITATIVE ANALYSIS FOR 304 STAINLESS STEEL COUPON EXPOSED IN THE REVERBERATORY ALUMINUM MELTING FURNACE RECUPERATOR.

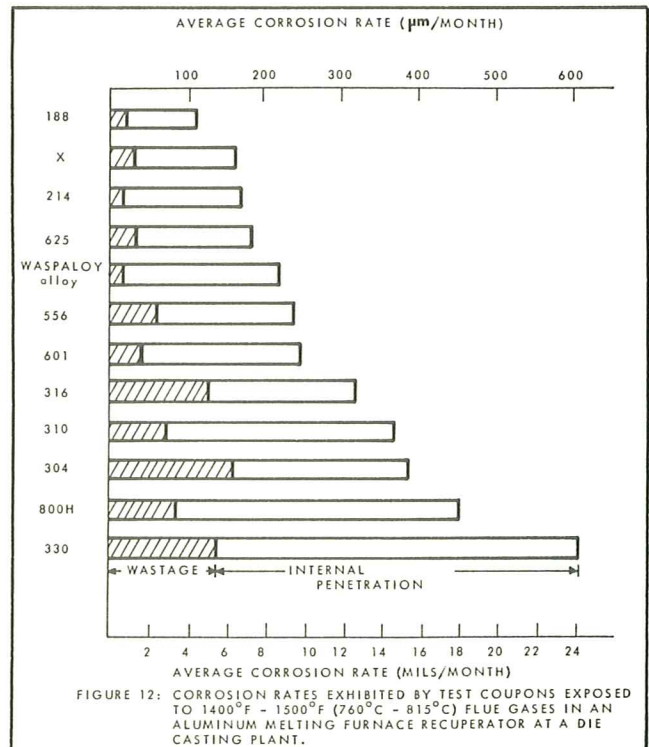
Results of this test exposure are given in Figure 12 for twelve commercial materials, and typical through-thickness photomicrographs for several materials are presented in Figure 13. It is immediately clear that the rates of corrosion observed in this case are as much as an order of magnitude lower than those in the previous case. This is likely a function both of the lower temperature and, perhaps even more importantly, of the absence of potassium-, sodium- and sulfur-containing compounds, excluded as a consequence of not employing fluxing agents.

The best performing material in these tests was alloy 188, a cobalt-base alloy. The next best materials were all nickel-base, including the high-aluminum alloy 214. None of these materials suffered large wastage of metal, but rather the bulk of the degradation observed was in the form of internal penetration. As may be seen in Figure 13, this internal penetration was in many cases along grain boundaries. Sometimes, as in the case of alloy 601, this grain boundary attack was accompanied by severe intragranular void formation. This is believed to be associated with the secondary attack of matrix carbides which precipitate after carbon freed from chlorinated grain boundary carbides has diffused out into the matrix. Such behavior has been observed in laboratory tests conducted by Elliott et al.⁽¹⁰⁾ for materials such as alloy 800H in air plus 2% Cl₂ environments at 1000°C (1832°F).

FIGURE 12: CORROSION RATES EXHIBITED BY TEST COUPONS EXPOSED TO 1400°F - 1500°F (760°C - 815°C) FLUE GASES IN AN ALUMINUM MELTING FURNACE RECUPERATOR AT A DIE CASTING PLANT.

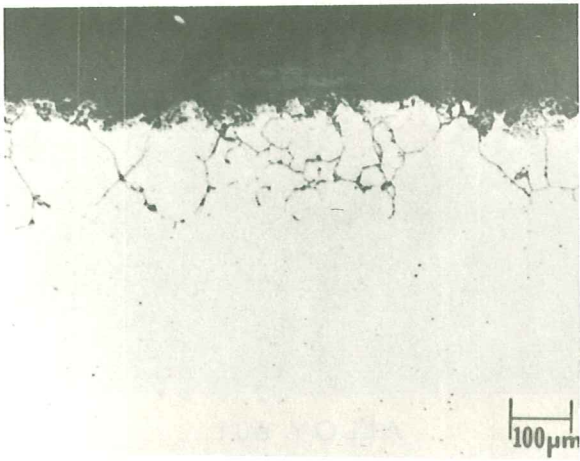
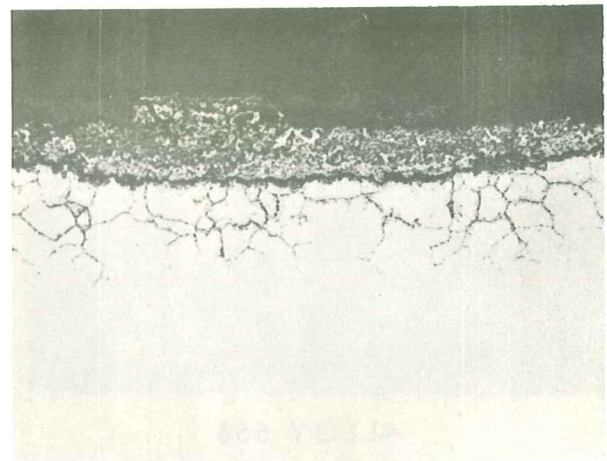
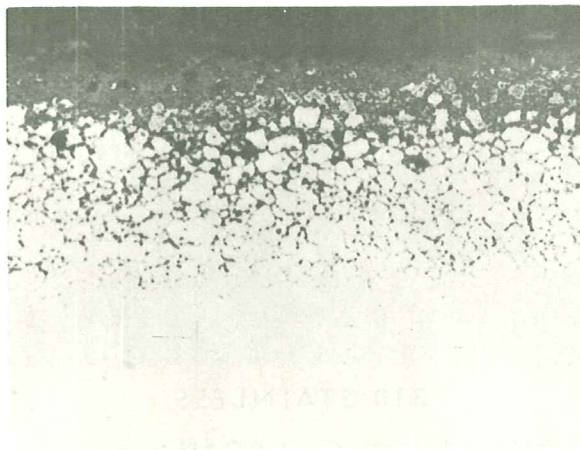
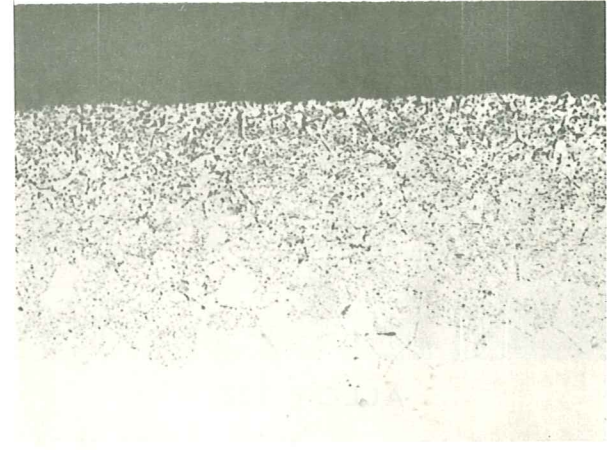
FIGURE 13: MICROSTRUCTURES OF VARIOUS ALLOY COUPONS EXPOSED IN THE ALUMINUM MELTING FURNACE RECUPERATOR AT THE DIE CASTING PLANT.

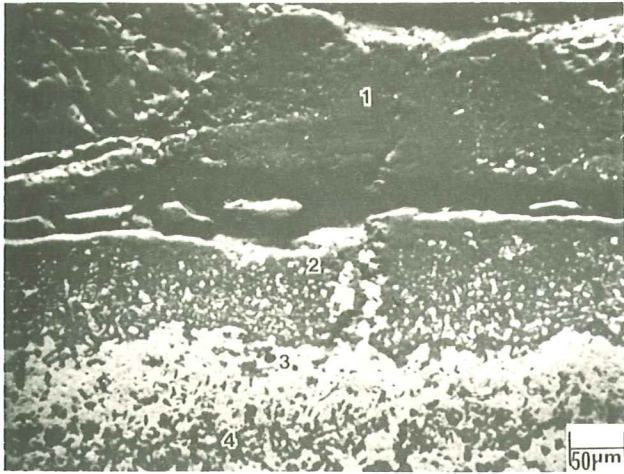
As for internal attack, all of the alloys which were at the top of the list in terms of performance, with the exception of alloy 214, contain sufficient amounts of molybdenum, tungsten, columbium, tantalum or titanium to have primary carbides which are low in chromium content (M_6C , MC) rather than chromium-rich carbides ($M_{23}C_6$, M_7C_3). Such carbides should not be as readily chlorinated as the chromium-rich carbides. Neither would they be associated with chromium depletion in the surrounding matrix. Both of these factors could contribute to the observed higher level of resistance in the field exposure as compared to the higher-temperature laboratory tests. For the alloys which form principally chromium-rich carbides, the slowed rate of chlorine and oxygen ingress would yield less overall internal penetration, but these carbides and surrounding chromium-depleted areas would be more heavily attacked. Typical massive internal chromium chloride formation and associated chromium depleted metal areas are shown for 310 stainless steel in the SEM photomicrograph and EDAX analyses of

FIGURE 14: SEM THROUGH-THICKNESS MICROGRAPH AND SELECTED AREA EDAX SEMI-QUANTITATIVE ANALYSES FOR 310 STAINLESS STEEL COUPON EXPOSED IN THE ALUMINUM DIE CASTING PLANT MELTING FURNACE RECUPERATOR.

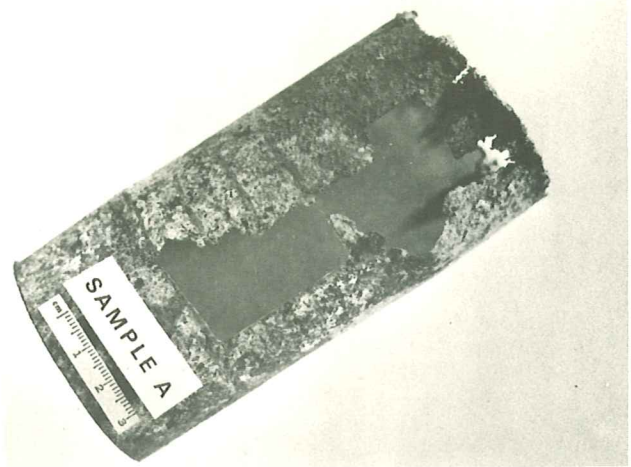
A failure analysis was performed for tubes of type 316 stainless steel exposed in the recuperator of a zinc melting furnace. A silicon carbide crucible placed in a combustion chamber and heated by combustion of natural gas was used to melt and vaporize zinc. Supposedly isolated from the molten/vapor zinc environment, the combustion flue gases were passed through the recuperator to preheat combustion air. The flue gas temperature was reported to be 1800°F (980°C), while preheat combustion air temperature was given as 1000°F (540°C), leaving actual tube metal temperatures somewhere in between. All of the Type 316 stainless steel tubes examined from the recuperator front row failed after only two to three months service due to severe corrosion attack. A section of a corroded tube from the first row in the recuperator is shown in Figure 15.

Apparently, zinc leakage through the crucible into the combustion chamber reacted with oxygen in the flue gas to form zinc-rich oxides on the tube surfaces. This resulted in localized accelerated oxidation attack and the eventual perforation of the tubes in the front row of the recuperator. The better performance

FIGURE 15: PERFORATED 316 STAINLESS TUBE FROM THE FIRST ROW OF A RECUPERATOR IN A ZINC MELTING FURNACE. TUBE FAILED AFTER 2 OR 3 MONTHS EXPOSURE TO 1800°F (980°C) FLUE GASES.

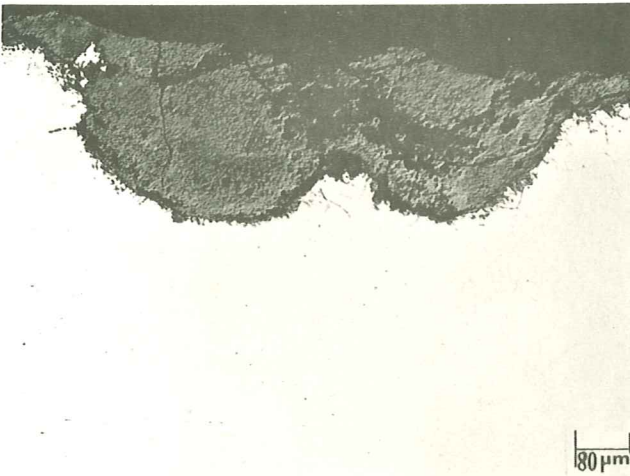
Metallographic examinations were performed for the failed tube from the front row of the recuperator and a tube from the third row of the recuperator. Samples were taken at locations facing the direction of flue gas flow. Typical through-thickness microstructures are shown in Figures 16 and 17, respectively. The perforated tube from the front row exhibited clear signs of localized catastrophic oxidation, while the tube in the third row was far less severely attacked. The scale, in both cases, was found to be essentially iron-chromium-rich presumably spinel-type oxide containing substantial amounts of zinc contamination, all confirmed by SEM/EDAX analysis. Some small amount of sub-scale sulfide formation was also noted.

FIGURE 16: THROUGH-THICKNESS MICROSTRUCTURE OF 316 STAINLESS RECUPERATOR TUBE WHICH FAILED IN ZINC MELTING FURNACE APPLICATION. SIDE FACING FLUE GAS FLOW IN THE FIRST ROW OF TUBES.

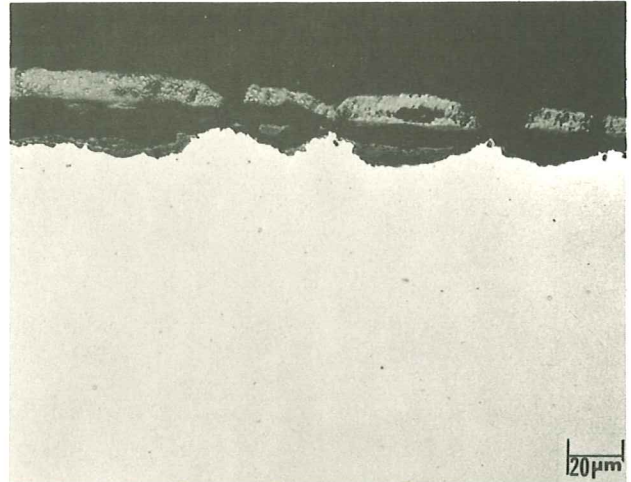
of the tubes in the third row may be due to both the effects of lower temperature, since the flue gases would be cooler at this point, and the depletion of zinc or zinc oxide from the flue gas stream by the deposition/reaction with the tubes in the first two rows.

FIGURE 17: THROUGH-THICKNESS MICROSTRUCTURE OF 316 STAINLESS RECUPERATOR TUBE WHICH FAILED IN ZINC MELTING FURNACE APPLICATION. SIDE FACING FLUE GAS FLOW IN THE THIRD ROW OF TUBES.

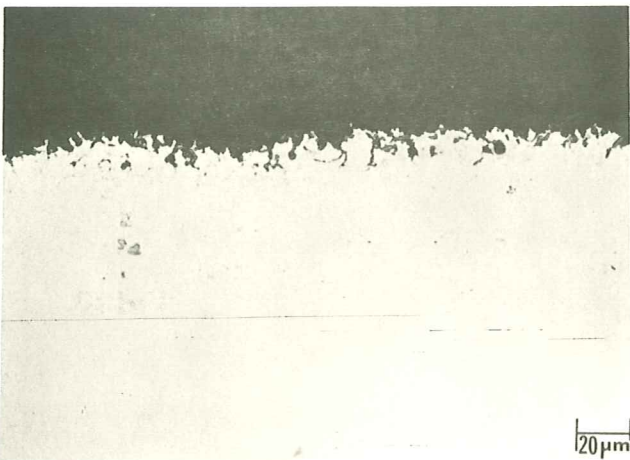
Figure 18 is a through-thickness photomicrograph of the microstructure of a 309 stainless steel baffle plate located between the third and fourth row of tubes. This plate, which was uncooled, probably experienced flue gas temperatures close to those of the front row of tubes. Since the degree of attack exhibited by the plate is not much more than that of the cooled tube in the third row, it would appear that zinc vapor or zinc oxide content in the flue gas may be a more overriding consideration than temperature in this case. Of course, the difference between the performance of Type 309 versus Type 316 stainless steel clouds the issue to some extent.

FIGURE 18: THROUGH-THICKNESS MICROGRAPH OF 309 STAINLESS BAFFLE PLATE FROM ZINC MELTING FURNACE RECUPERATOR.
