MATERIALS PROBLEMS IN INCINERATION PLANTS

S. BARANOW, G. Y. LAI, M. F. ROTHMAN

Cabot Corporation
Kokomo, Indiana

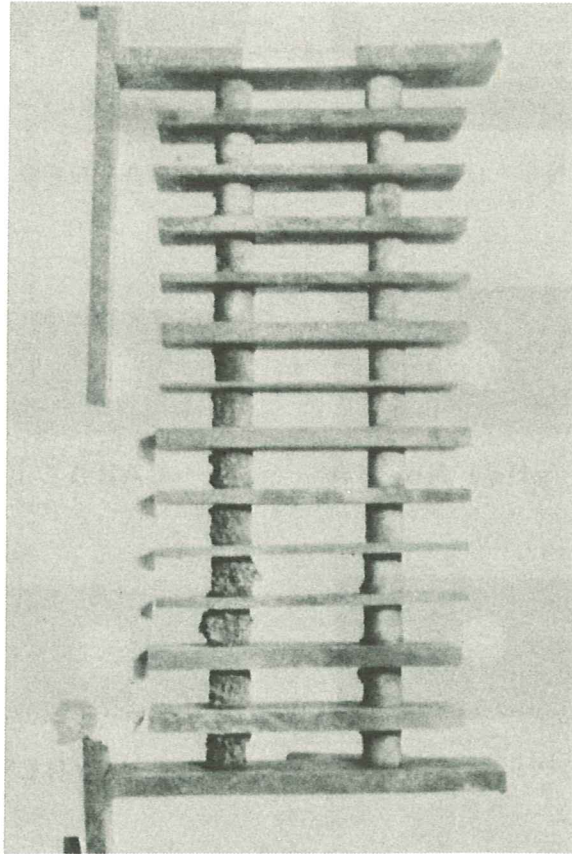
Figure 1 is a photograph of the rack exposed to the boiler-side environment subsequent to brushing off loose debris. The incinerator side was similar in appearance. Figures 2 and 3 show the appearance of each coupon after exposure. The coupons were cathodically descaled in a salt bath in order to remove corrosion scales formed on the specimens. Average metal losses were then calculated from the weight change before and after testing. The continuous internal penetration (CIP) was determined metallographically by examining a cross-sectional area of the descaled coupon.

FIG. 1 AS-RECEIVED BOILER-SIDE TEST RACK AFTER TWO-MONTH EXPOSURE TO FLUE GASES

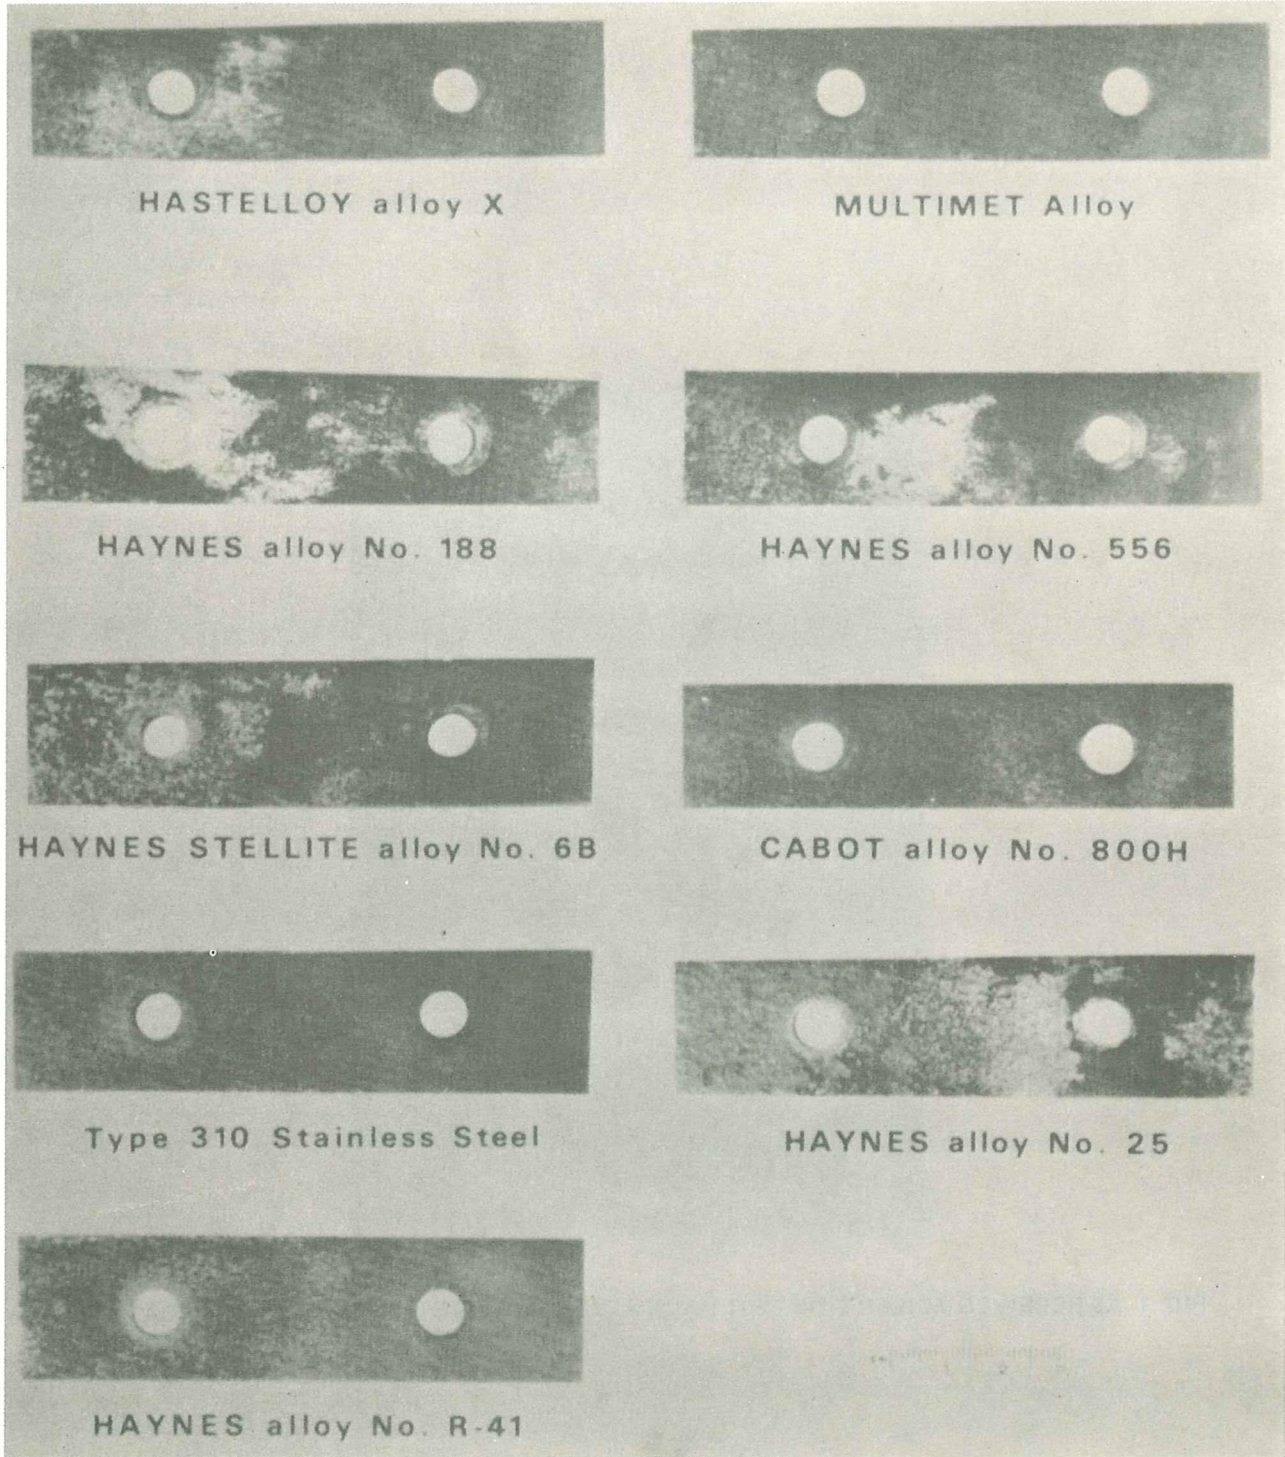
FIG. 2 BOILER-SIDE TEST COUPONS

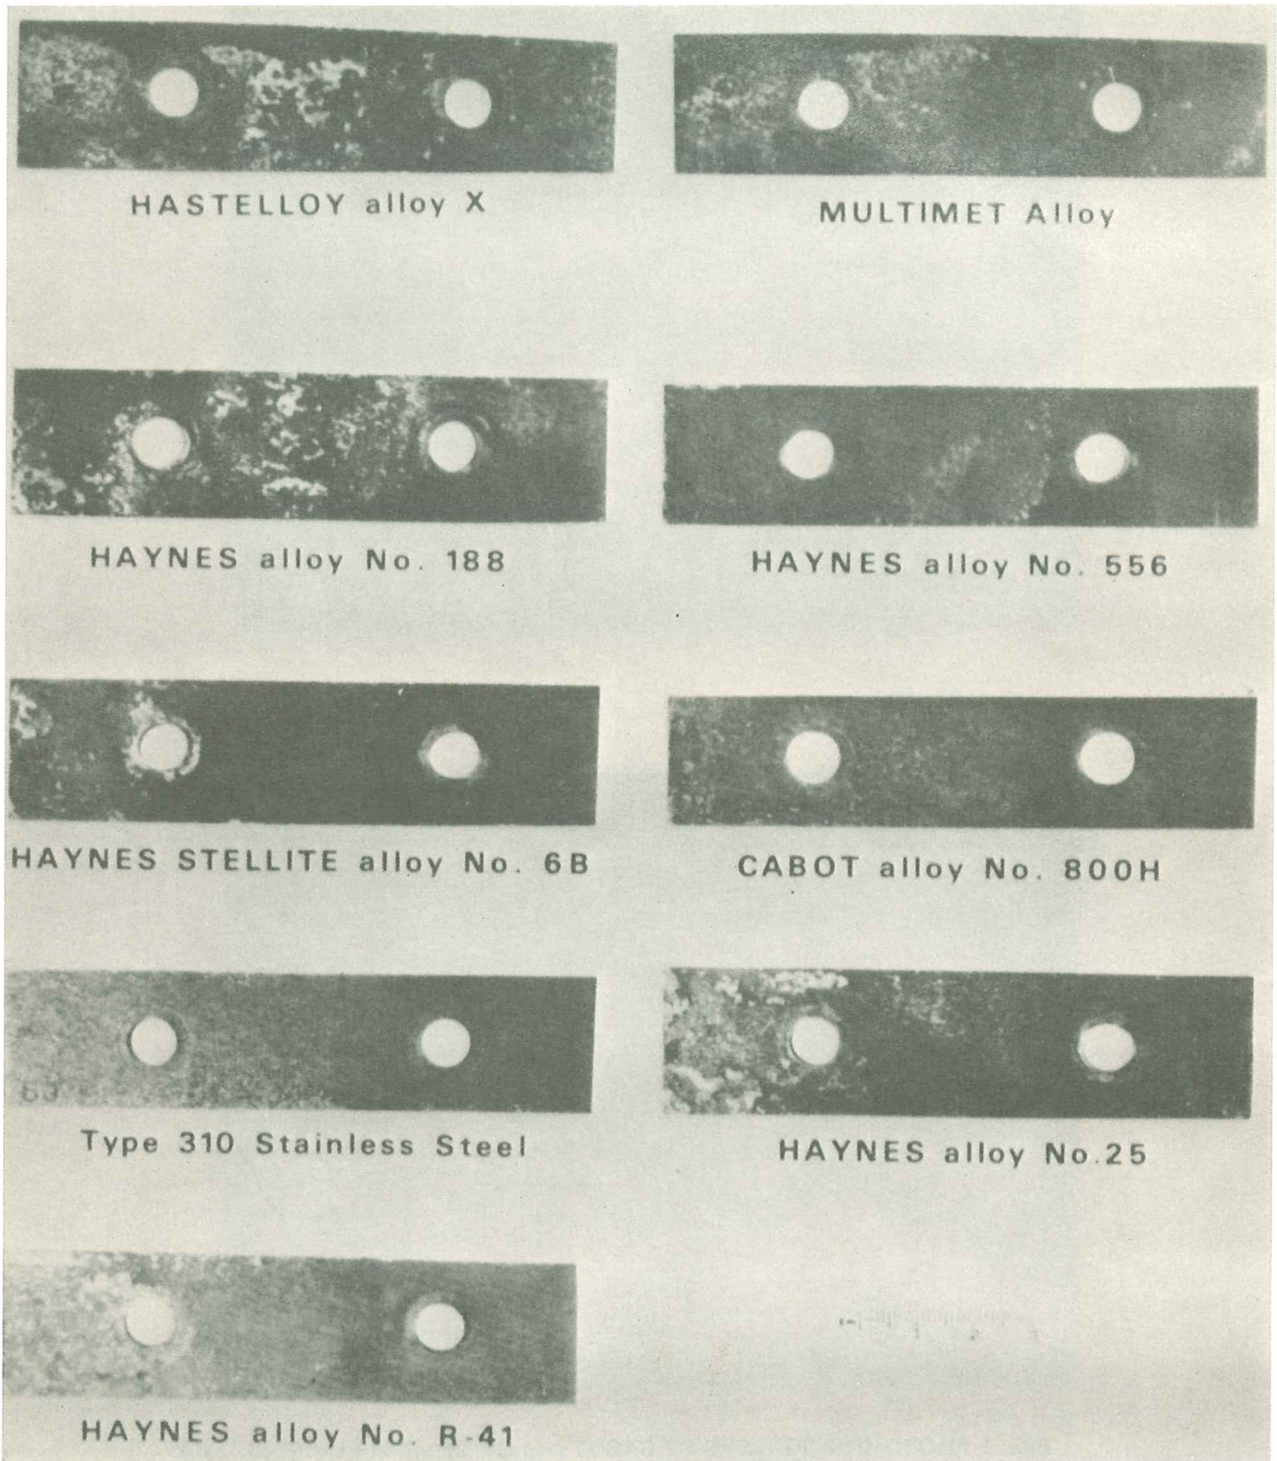
FIG. 3 INCINERATOR-SIDE TEST COUPONS

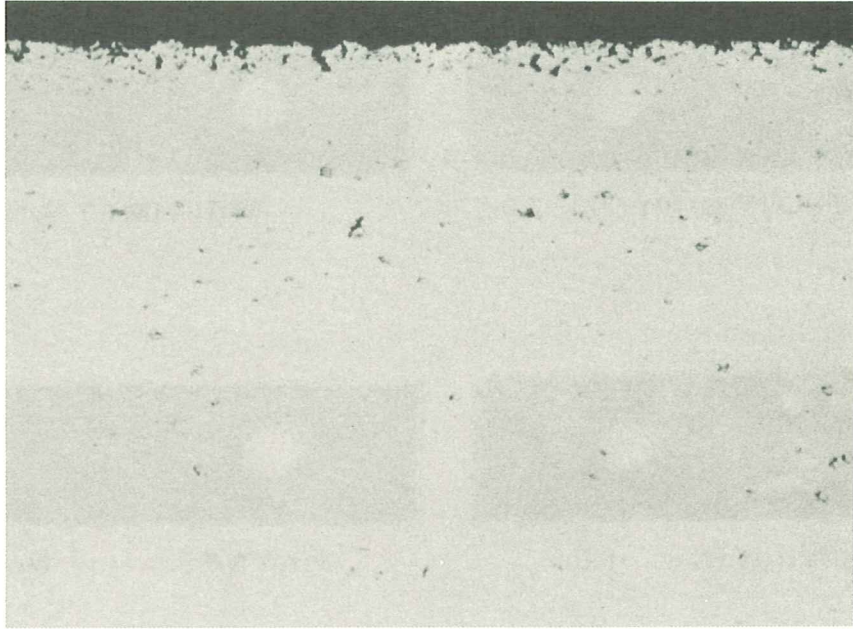
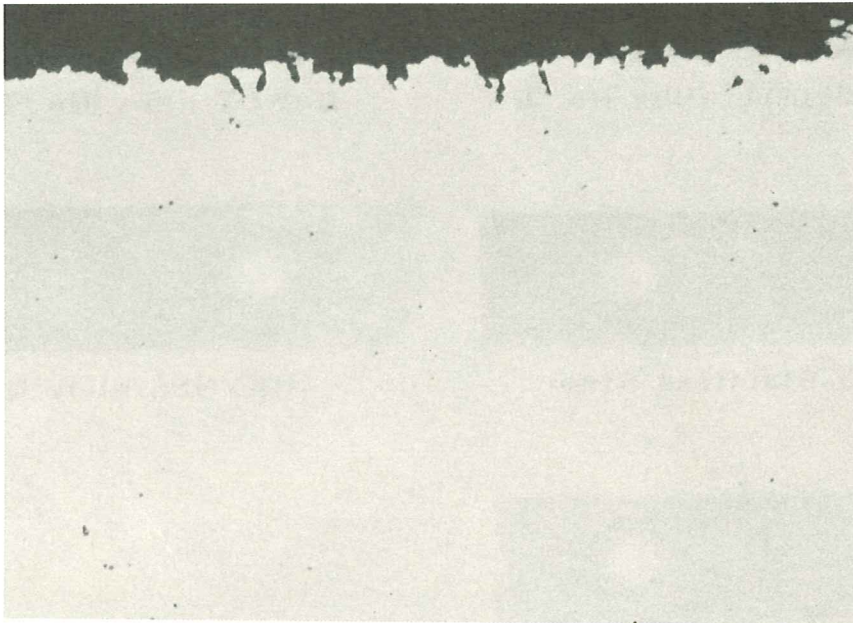
Metal wastages (or metal losses) were found to be relatively small for all the alloys in either the incineration or boiler side. Internal corrosion attack upon alloys was found to be greater in the boiler side than in the incinerator side. This is illustrated in Figs. 4, 5, and 6.

The high concentration of titanium found in the scale of CABOT[®] alloy No. R-41 is believed to be attributed to the titanium oxide formed on the alloy during exposure. (Alloy R-41 is the only alloy tested with a sufficient level of titanium to form titanium oxides.)

All the incinerator-side coupons exhibited very high levels of titanium and silicon along with lesser amounts of zinc and calcium. These impurities were presumably from the wastes being incinerated. No chlorine or chlorides were detected in the scales. This cannot rule out the possibility of the involvement of Cl_2 and/or HCl in the high-temperature corrosion, since metal chlorides (if formed) can escape from the corrosion products because of their high vapor pressures. SEM-EDX analyses performed on the through sections of these selected alloys confirmed that the internal phases seen in Fig. 4, 5, and 6 were oxides. No sulfides were detected.

FIG. 4 PHOTOMICROGRAPHS OF CABOT ALLOY NO. R-41 COUPONS: 250X
(A) INCINERATOR SIDE; (B) BOILER SIDE

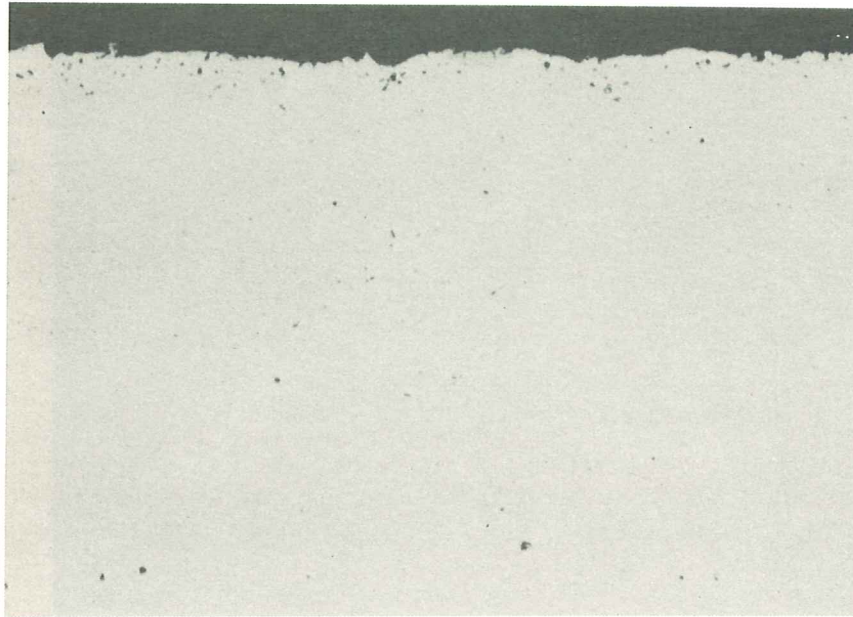
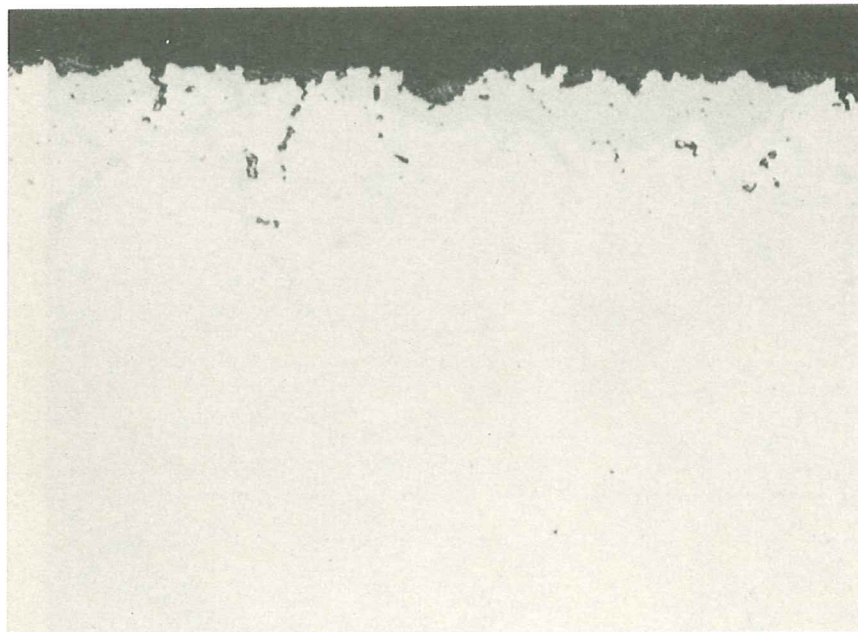
FIG. 5 PHOTOMICROGRAPHS OF HASTELLOY ALLOY X COUPONS: 250X;
(A) INCINERATOR SIDE; (B) BOILER SIDE

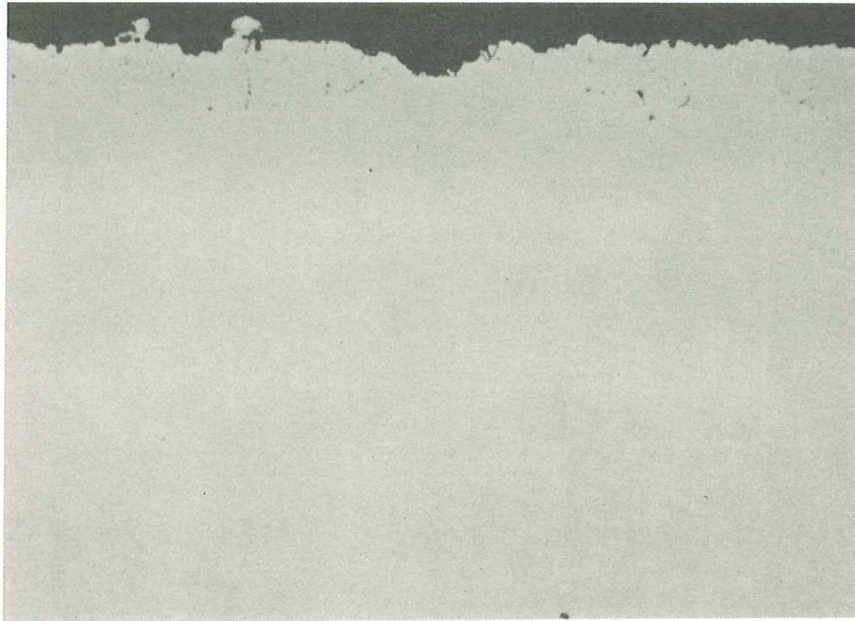
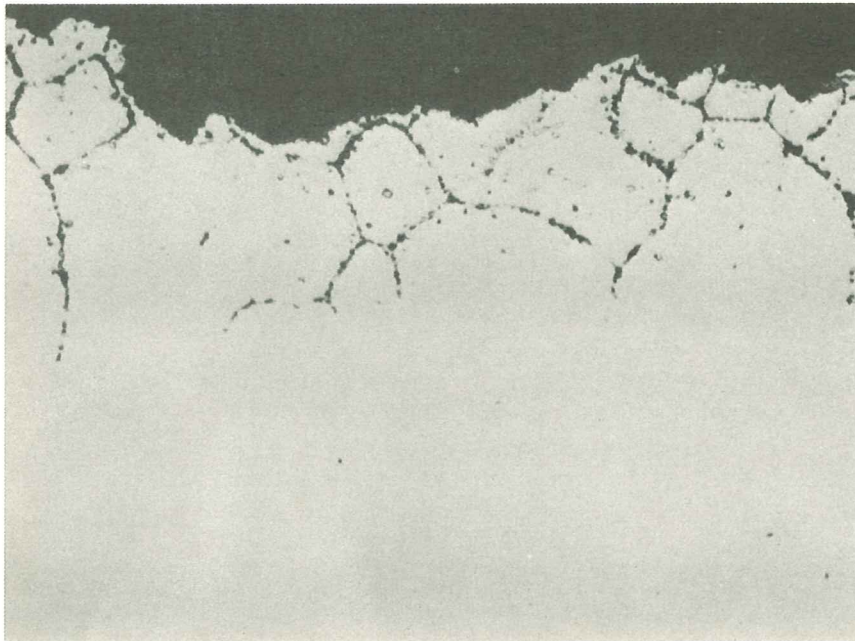
**FIG. 6 PHOTOMICROGRAPHS OF HAYNES ALLOY NO. 25 COUPONS; 250X;
(A) INCINERATOR SIDE; (B) BOILER SIDE**

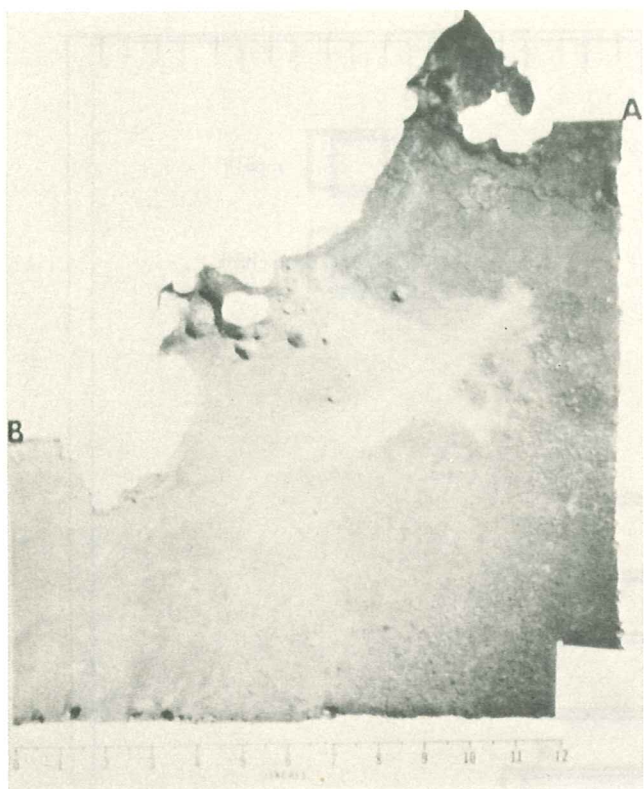
FIG. 8 PHOTOGRAPH OF AS-RECEIVED PLATE

This case is an example of how performing an analysis of an actual part that failed in an incineration facility led to a sufficient understanding of the field environment to allow laboratory test data to be used with confidence. A large baffle plate fabricated from HASTELLOY alloy X had failed in service in an incinerator burning waste oil. The service temperature was not known. A photograph of the as-received plate is shown in Fig. 8, after samples had been cut from Locations A and B.

Considering these results, and the results of tests similar to those presented in Table 3, HAYNES alloy No. 188 was recommended as an alternate material of construction in view of its excellent combined resistance to both sulfidation and oxidation, its ready fabricability, and the small degree of added over-temperature capability afforded to cobalt-base alloys over lower melting point nickel-base alloys.

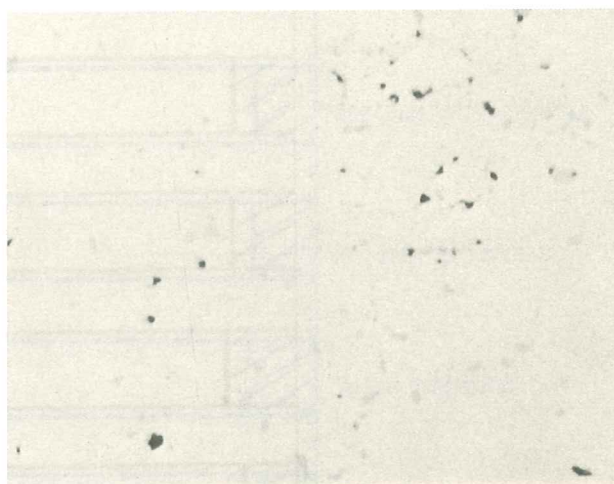
FIG. 9 PHOTOMICROGRAPH OF AN AREA WITHIN SECTION A, FIG. 8: 200X

Figure 9 is a photomicrograph of a region within Area A on the baffle. The nature of the carbide morphology is clearly indicative of incipient melting having taken place. The blocky particles observed were identified by SEM-Energy Dispersive X-ray analysis to be chromium- and manganese-rich sulfides. Figure 10 is a photomicrograph of an area at and near the surface of Area B on the baffle. Although the microstructure appears normal, when subjected to SEM/EDX analysis, the scale was found to contain some form of nickel sulfide as well as chromium oxide.

Based upon these observations, it was clear that the major characteristic of the service environment related to the cause of failure was overheating combined with sulfidation/oxidation. Laboratory sulfidation-resistance tests were conducted at 1600°F (871°C) for 215 hr in a gas mixture consisting of 5 percent H₂-5 percent CO-1 percent CO₂-0.15 percent H₂S-0.1 percent H₂O-Balance Ar (by volume percent). Results are presented in Fig. 11.

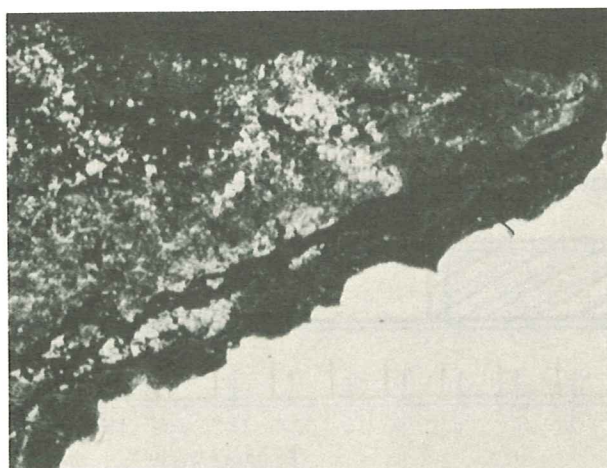
FIG. 10 PHOTOMICROGRAPH OF SECTION B, FIG. 8, AT THE SURFACE, 100X
