# The Corrosion Behavior of a New Sulfidation-Resistant Alloy in a Sulfidizing/Oxidizing/Carburizing Atmosphere

G. Y. Lai\*, J. F. Norton\*\* and F. G. Hodge\*

\* Haynes International, Inc., 1020 West Park Avenue  
Kokomo, Indiana, USA

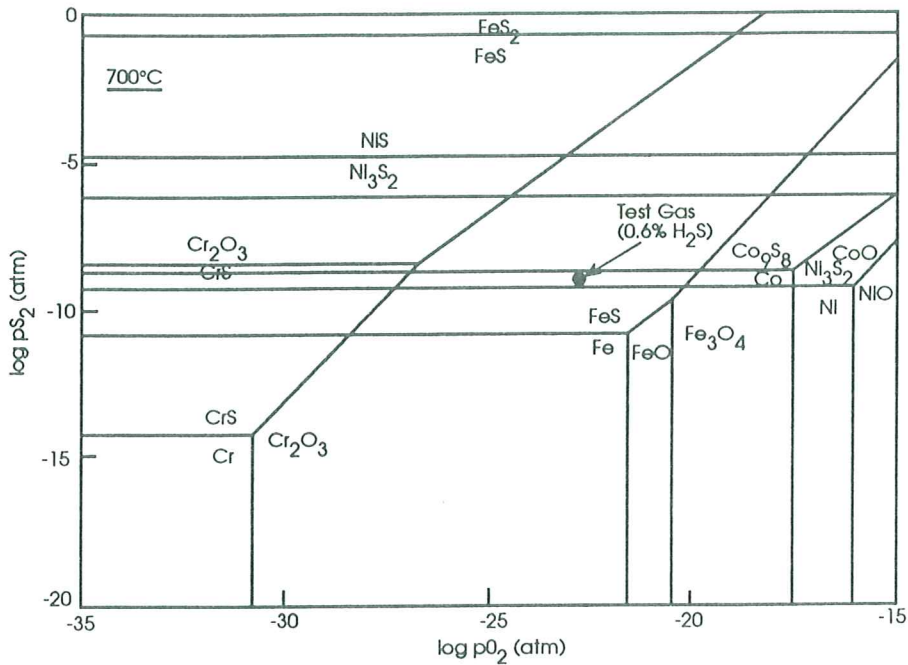
Fig. 1 - M-O-S thermodynamic phase stability diagram at 700°C (1292°F).

The test gas mixture consisted of 7% CO, 1.5% H<sub>2</sub>O, 0.6% H<sub>2</sub>S and balance H<sub>2</sub> (vol %). This gas composition was selected such that, at the test temperature of 700°C and assuming equilibration of the gas mixture, phases of Cr<sub>2</sub>O<sub>3</sub>, CrS, FeS and Ni<sub>3</sub>S<sub>2</sub> are thermodynamically stable at the gas-metal interface. The thermodynamic potentials of the environment at the test temperature were:  $P_{O_2} = 1 \times 10^{-23}$  atm,  $P_{S_2} = 1 \times 10^{-9}$  atm, and  $a_c = 0.3-0.4$ . The environment in terms of sulfur and oxygen potentials is plotted in a M-O-S stability diagram, as shown in Figure 1.

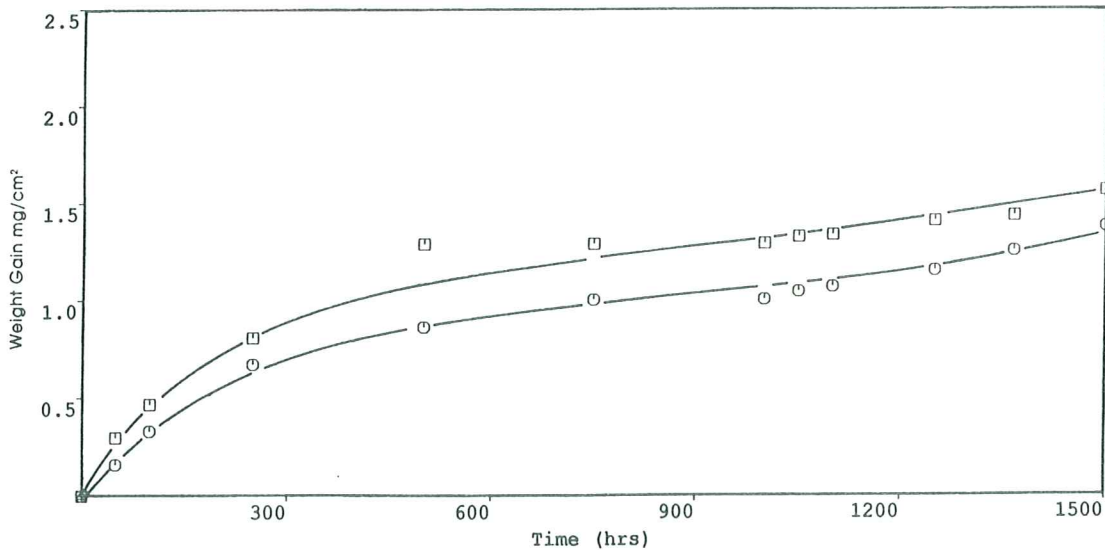
Fig. 2 - Gravimetric data for HR-160 alloy tested at 700°C (1292°F) in  $H_2-7CO-1.5H_2O-0.6H_2S$ .

to 1500 hours are summarized in Figure 2. Duplicate tests showed good reproducibility. The corrosion kinetics obeyed a parabolic law with no evidence of breakaway corrosion.

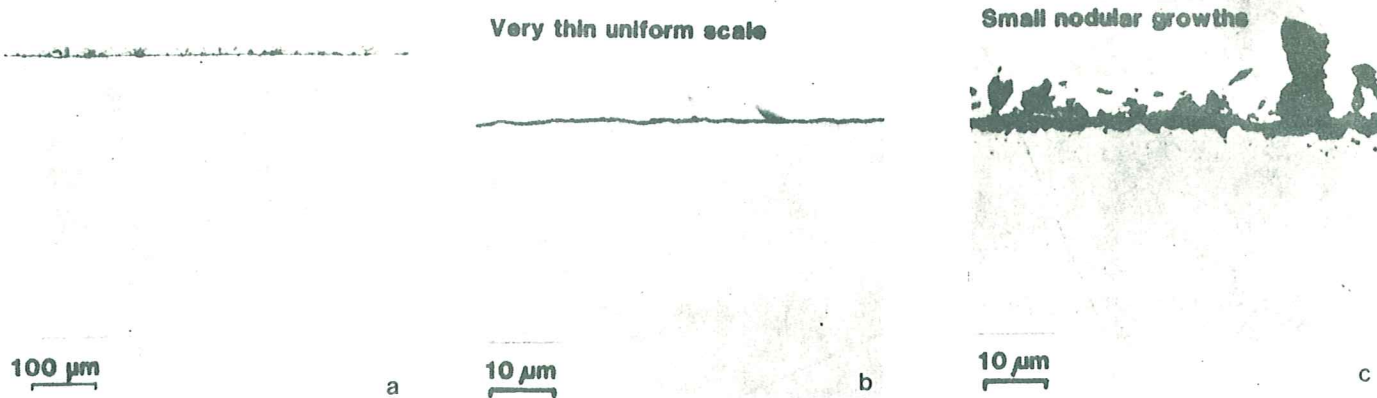
Fig. 3 - Optical photomicrographs showing an oxide scale with sulfide nodules over the oxide scale for HR-160 alloy exposed at 700°C (1292°F) for 100h. The specimen was nickel-plated prior to mounting.

Examination of the cross-section of the sample exposed for 100 hours revealed a thin oxide scale (Fig. 3b). There were nodules, in some areas, overlying the oxide scale (Fig. 3c). These nodules were found by EDX analysis to be Cr-rich sulfides (Fig. 4). X-ray diffraction analysis of the sample surface confirmed the presence of  $Cr_2S_4$ . No evidence of  $Cr_2O_3$  was detected by x-ray diffraction, presumably the oxide scale was too thin. EDX analysis on the surface area not covered by sulfide nodules revealed high Cr along with Si, Ni, Co and Fe (Fig. 4a).

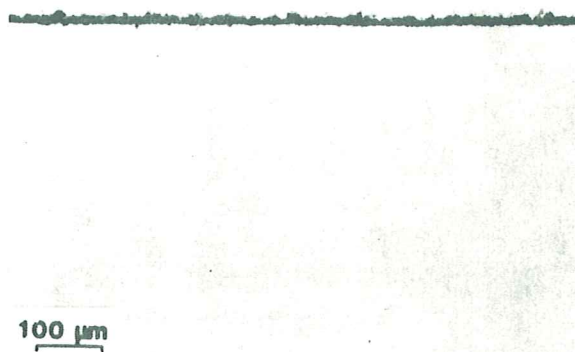
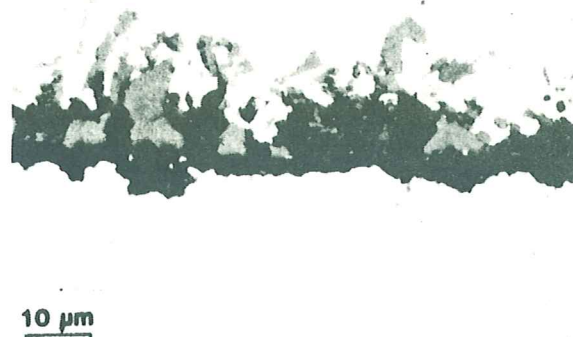
Fig. 5 - Optical photomicrographs showing the chromium oxide scale with chromium sulfides formed on top of the oxide scale for HR-160 alloy tested at 700°C (1292°F) for 500h. The specimen was nickel-plated prior to mounting.

was completely covered by Cr sulfide nodules. These nodules were relatively fine, as shown in Figs. 5 and 6. They were again identified as  $\text{Cr}_3\text{S}_4$ . In addition, a  $\text{Cr}_2\text{O}_3$  scale was detected by x-ray diffraction.

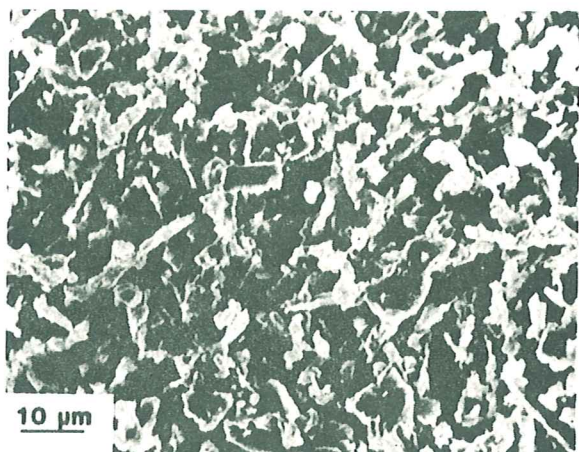
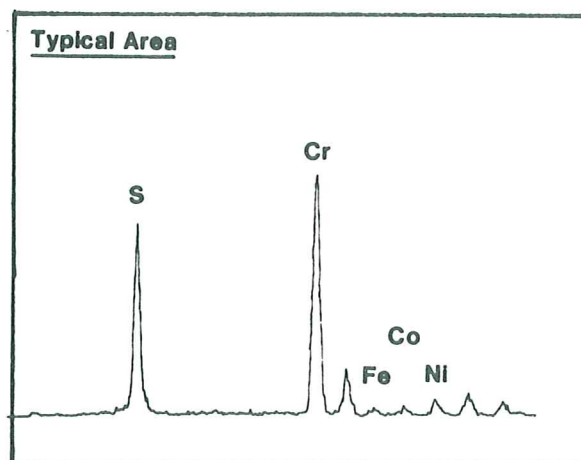
Fig. 6 - SEM/EDX analysis of the surface of the HR-160 specimen tested at 700°C (1292°F) for 500 h.

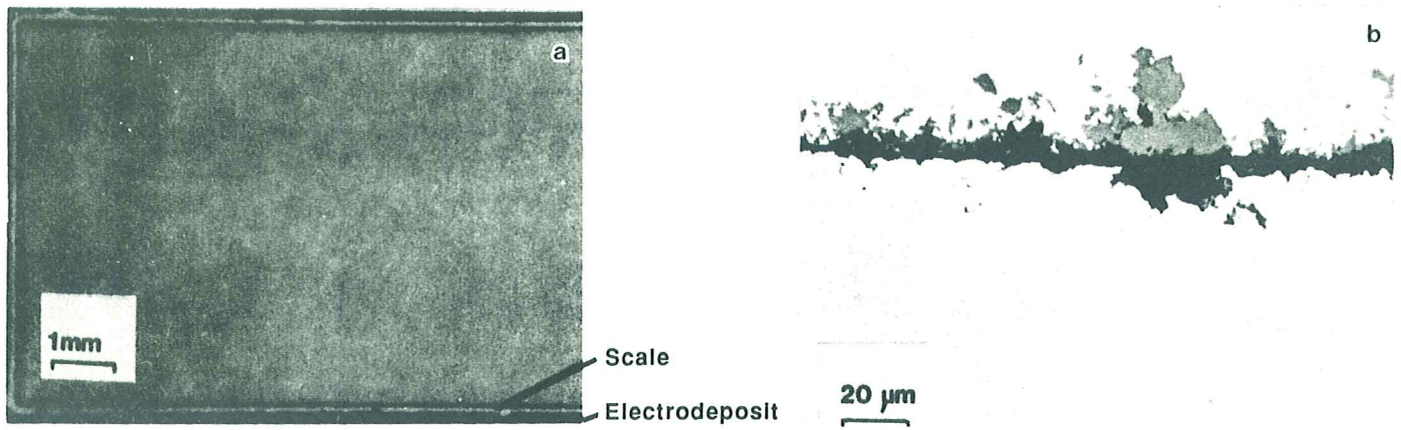
Fig. 7 - Optical photomicrographs showing (a) the cross section of the specimen and (b) chromium sulfides over the chromium oxide scale for HR-160 alloy tested at 700°C (1292°F) for 1500 hours. The specimen was nickel-plated prior to mounting.

Continued exposure to 1000 and 1500 hours resulted in little change of the scales. The oxide scale was still very thin (Fig. 7). Phases detected by x-ray diffraction were again  $\text{Cr}_2\text{O}_3$  and  $\text{Cr}_3\text{S}_4$ . The thickness of the chromium sulfides after 1500 hours varied from 5 to 20  $\mu\text{m}$ . Very little internal sulfide precipitation was evident underneath the continuous chromium oxide scale. The specimen exposed for 1500 hours still appeared to be in excellent shape, as shown in Fig. 7a.

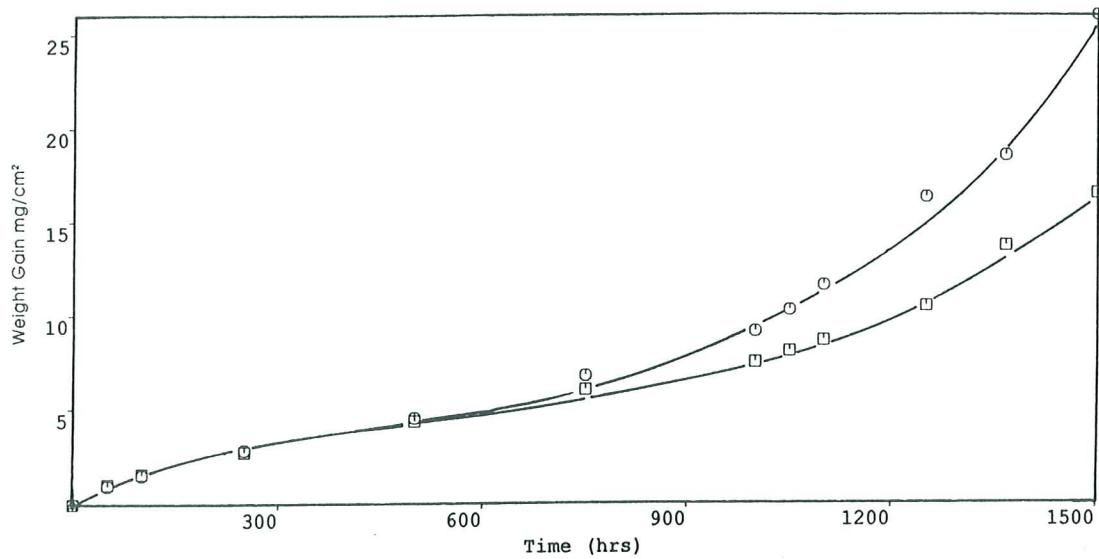
Fig. 8 - Gravimetric data for 556 alloy tested at 700°C (1292°F) in  $H_2-7CO-1.5H_2O-0.6H_2S$

556 ALLOY - Gravimetric data of duplicate tests for 556 alloy are summarized in Fig. 8. Reproducibility was, again, quite good. The alloy corroded according to a parabolic law for times up to about 900 hours. Further exposure resulted in breakaway corrosion.

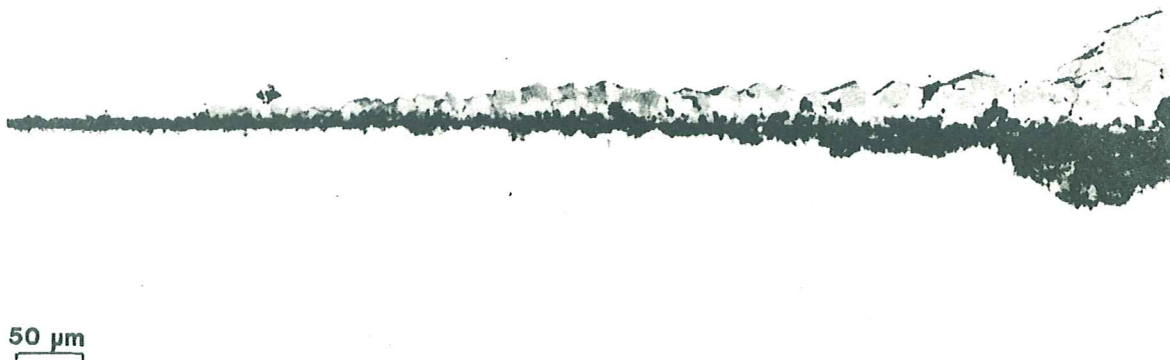
Fig. 9 - Optical photomicrograph showing that the severity of internal (subscale) attack increases with the increasing thickness of the external sulfide scale for 556 alloy tested at 700°C (1292°F) for 500h. The specimen was nickel-plated prior to mounting.

During the "protective" stage, the majority of the specimen surface was covered by external Cr-rich sulfides over the Cr-rich oxide scale. However, significant areas around corners and edges were covered by much thicker crystalline Fe-rich sulfides. These external Fe-rich sulfides became thicker as they

approached the corner or the edge. This is illustrated in Fig. 9. It is also noted that, in general, more severe subscale (or internal) attack was observed underneath heavy external sulfide scale. This is generally observed for other alloy systems as well. It implies that, as the oxide scale is losing its protectiveness, the external sulfide scale is beginning to thicken, while at the same time the underlying matrix suffers increased internal attack.

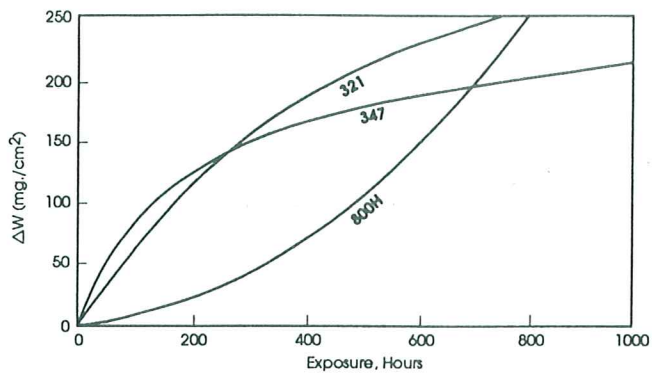
Fig. 10 - Gravimetric data for Type 321SS, Type 347SS and alloy 800H tested at 700°C (1292°F) in H<sub>2</sub>-7CO-1.5H<sub>2</sub>O-0.6H<sub>2</sub>S.

FE-NI-CR ALLOYS - Type 321SS, Type 347SS and Alloy 800H suffered severe corrosive attack in this environment. Gravimetric data for these three alloys are summarized in Fig. 10.

Both Type 321SS and Alloy 800H exhibited about 300 mg/cm<sup>2</sup> of weight gain after 1000 hours, and Type 347SS about 200 mg/cm<sup>2</sup> after 1000 hours. All three alloys suffered tremendous scaling, with significant spallation of the scales. This is illustrated in Fig. 11, which shows low magnification photomicrographs of the specimen cross sections of Alloy 800H after 100 and 1000 hours of exposure. EDX analysis of the scales indicated that these alloys formed mainly Fe-rich sulfides. For example, after 1000 hours, Fe-rich sulfides were observed for Type 347SS and Fe-rich sulfides and Fe-Ni sulfides were observed for Alloy 800H.
