333

March 25-29, 1985 / Sheraton Hotel
Hynes Auditorium / Boston, Massachusetts

SELECTION OF MATERIALS FOR COMBUSTION ENVIRONMENTS

ASSOCIATED WITH WASTE INCINERATION

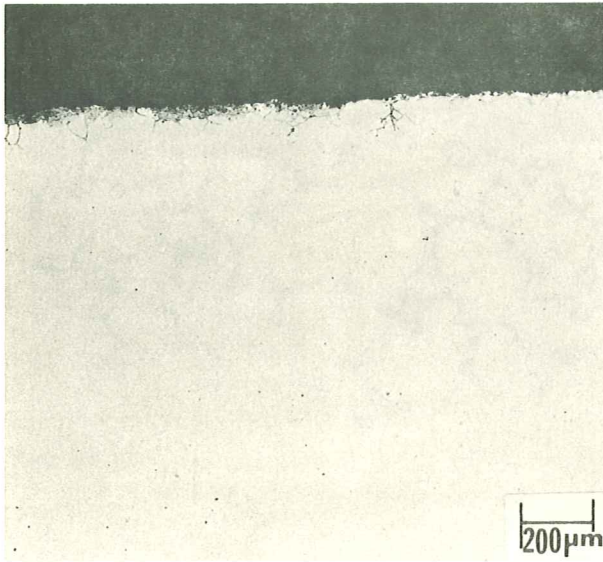
FIGURE 5: OPTICAL PHOTOMICROGRAPHS SHOW THE MORPHOLOGY OF ATTACK UPON SELECTED ALLOYS AFTER EXPOSURE IN A COMBUSTION ENVIRONMENT GENERATED BY INCINERATED PAINT SLUDGE. AS-POLISHED

No sulfur or sulfides were detected in the corrosion products for all alloys on the test rack with the exception of alloy 600 and Type 310 stainless steel. Chlorine was not detected in any samples tested. Figures 4 and 5 illustrate the morphology of corrosion for selected alloys. Chromium-rich sulphide phases were found to form underneath the oxide scale as is shown in Figure 6.

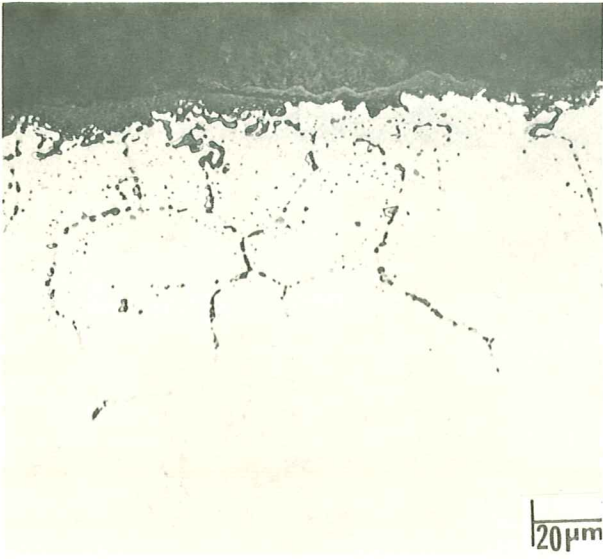
FIGURE 6: THE HIGH MAGNIFICATION PHOTOMICROGRAPHS OF ALLOYS EXPOSED IN THE INDUSTRIAL INCINERATOR SHOW THAT THE ATTACK INVOLVED THE PENETRATION OF SULFIDE PARTICLES IN THE HEAVILY ATTACKED SAMPLES SUCH AS 310 STAINLESS STEEL AND CABOT alloy NO. 600. AS-POLISHED

It is believed that oxidation was the dominant mode of attack for most alloys. Alloy 600, which possesses the highest nickel content suffered oxidation and sulfidation attack. The sulfur potential in the present combustion environments may not be very high. The use of greater than 10 percent excess air for combustion might also be instrumental in minimizing the sulfidation attack on the higher-alloyed nickel-base alloys.

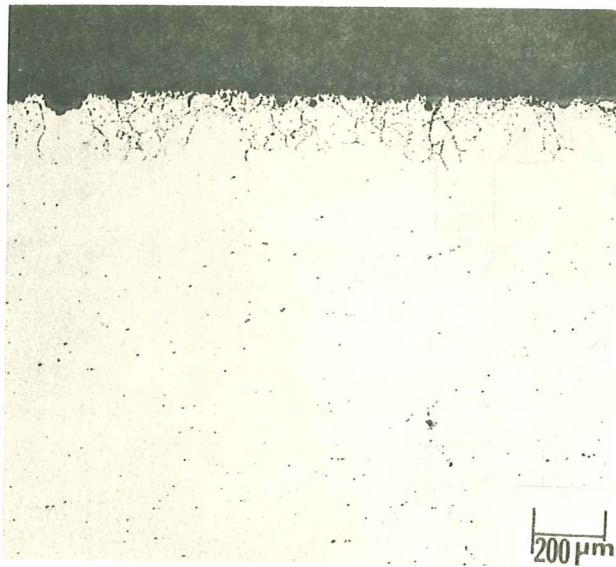
FIGURE 9: THE OPTICAL PHOTOMICROGRAPHS SHOW THE DEGREE OF ATTACK ON SAMPLES AFTER 417 HOURS OF ATTACK IN THE INCINERATION OF WOOD AND PACKAGING MATERIALS. AS-POLISHED

Samples which were removed from the test rack after exposure are shown in Figure 8. Visual examination revealed pitting attack for some alloys. The morphology of corrosion attack for selected alloys is illustrated in Figure 9. An SEM/EDS analysis of the corrosion products formed on selected alloys (e.g., alloy 800H and alloy 214) indicate the presence of sulfur and, in some cases, Zn and Ca.

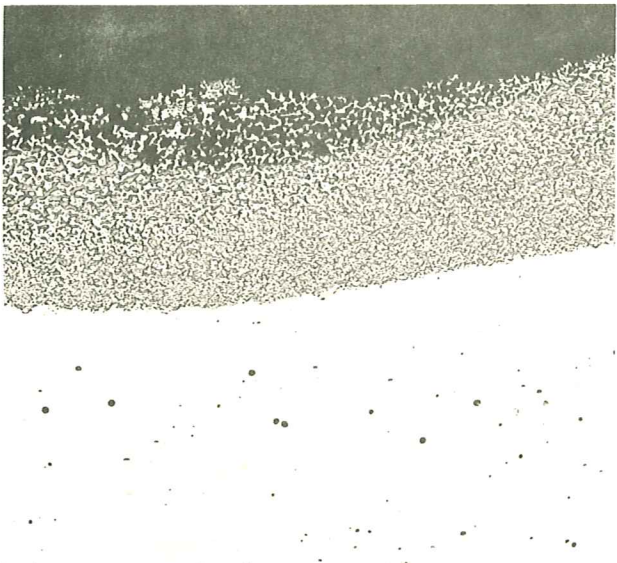
FIGURE 11:

THE OPTICAL PHOTOMICROGRAPHS SHOW THE MORPHOLOGY OF ATTACK ON SAMPLES EXPOSED IN A COMBUSTION ENVIRONMENT ASSOCIATED WITH MUNICIPAL WASTE INCINERATION AT 1450° - 1750° F FOR 950 HOURS (AS-POLISHED)

The morphology of corrosion attack for selected alloys is illustrated in Figure 11. An SEM/EDS analysis was performed on selected samples. Sulfides were found to form on some alloys. Figure 12 (a) shows a coupon of

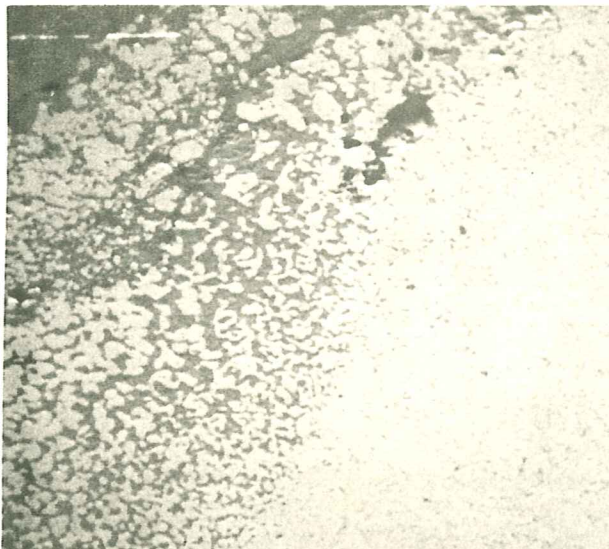
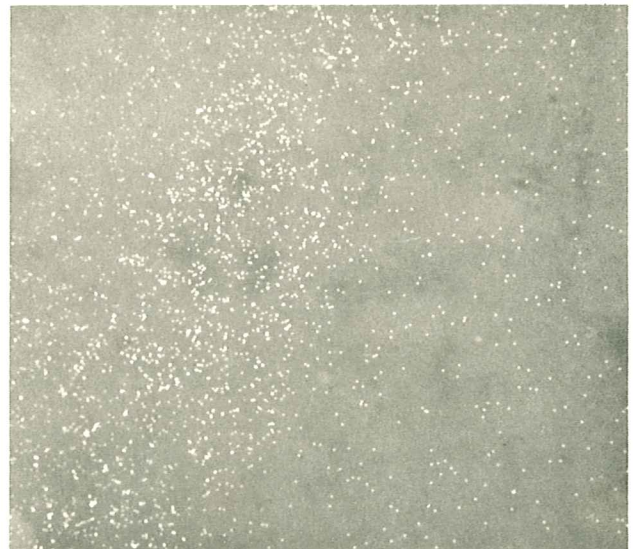
FIGURE 12: THE PHOTOGRAPH SHOWS THE HEAVY LOCALIZED ATTACK ON INCONEL alloy 690. THE PRIMARY CAUSE OF ATTACK WAS DETERMINED TO BE SULFIDATION AS IS SHOWN BY THE SULFUR DOT MAP. MAGNIFICATION: 100X; BSE

alloy 690 which was partially destroyed after the exposure. Examination of the cross section of the coupon revealed severe sulfidation attack. The sulfides formed on the alloy 690 sample are illustrated in Figure 12 (b and c) and were determined to be Cr-rich sulfides. The severe, localized attack was probably due to the formation of molten, Ni-rich and Cr-rich sulfides.
