MATERIALS PROBLEMS IN INCINERATION PLANTS

S. BARANOW, G. Y. LAI, M. F. ROTHMAN

Cabot Corporation
Kokomo, Indiana

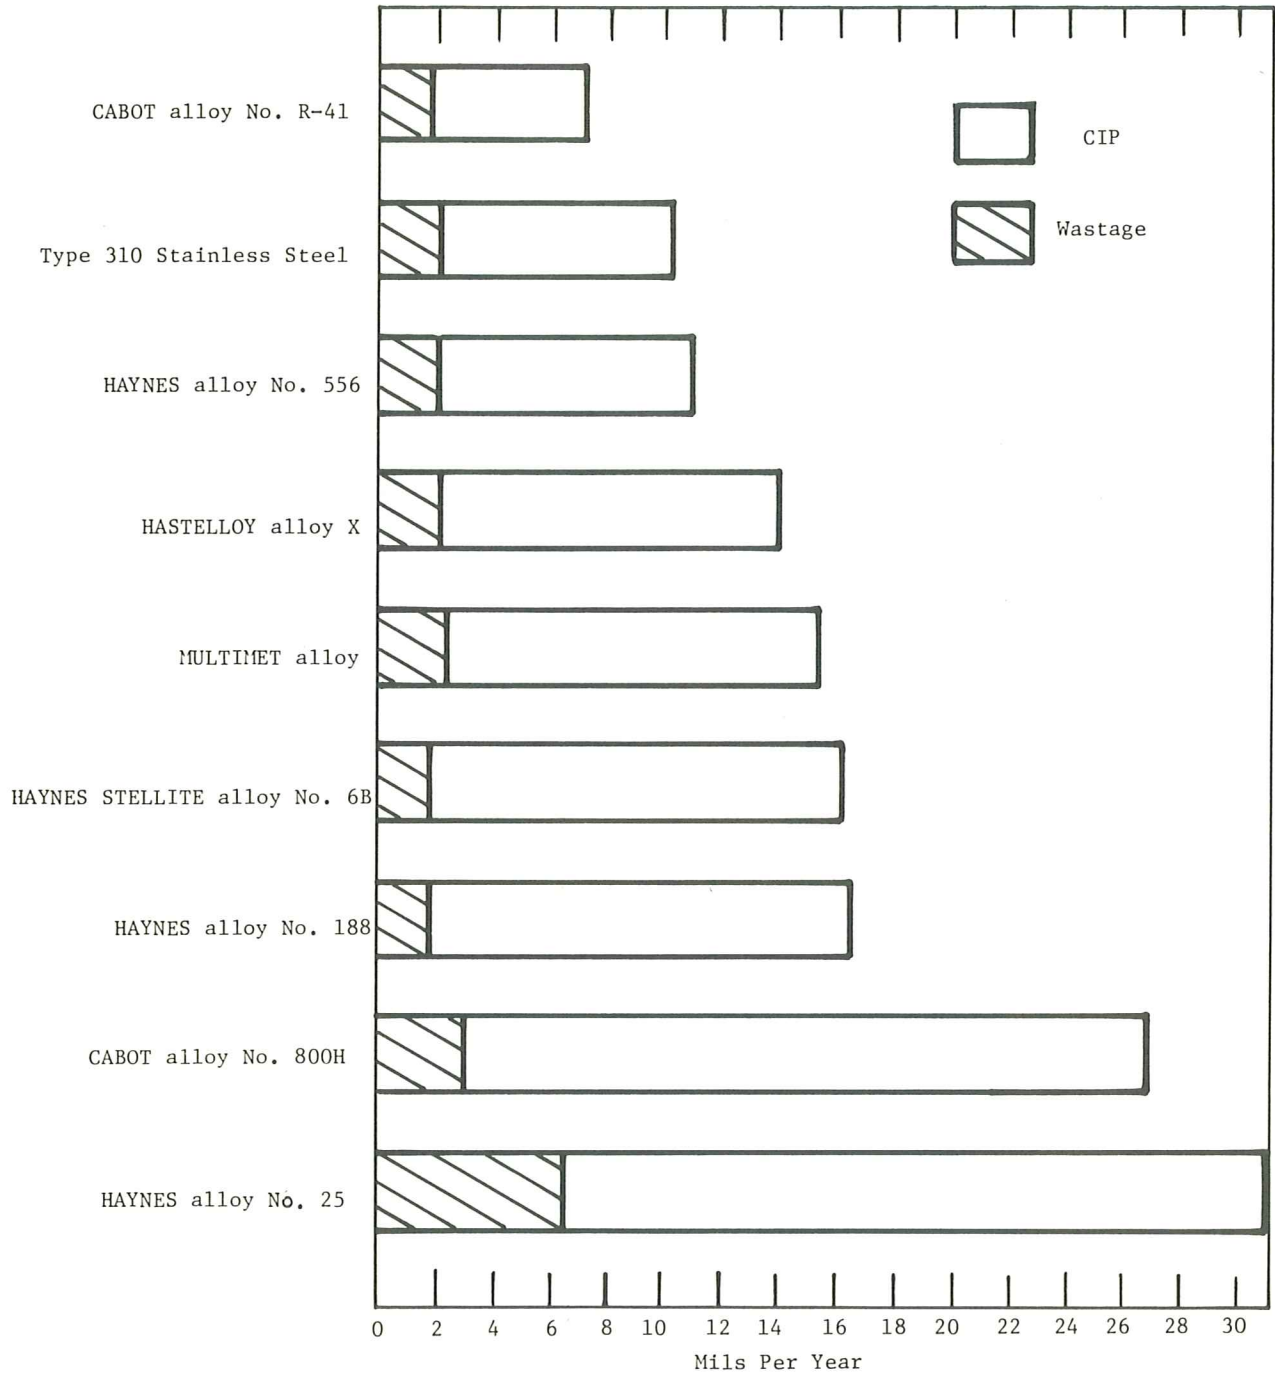
Since, in service, one side of the partition sees the boiler environment, and the other, the incinerator environment, corrosion rates were calculated by averaging the results for each set of specimens. This is shown in Fig. 7 where the corrosion rates are presented on a mils-per-year (μm -per-year) basis by assuming linear kinetics. As can be seen, the CIP is much more of a factor than the metal wastage for each alloy. The results indicate that CABOT alloy No. R-41 was the best performer followed by Type 310 stainless steel, HAYNES alloy No. 556, and HASTELLOY alloy X. After taking several factors into consideration, including thermal stability and fabricability, HASTELLOY alloy X, and HAYNES alloy No. 556 were recommended as suitable candidates for this application.

FIG. 7 COMPOSITE CORROSION RATES OF ALLOYS TESTED
 (BOILER-SIDE RATE + INCINERATOR-SIDE RATE)/2

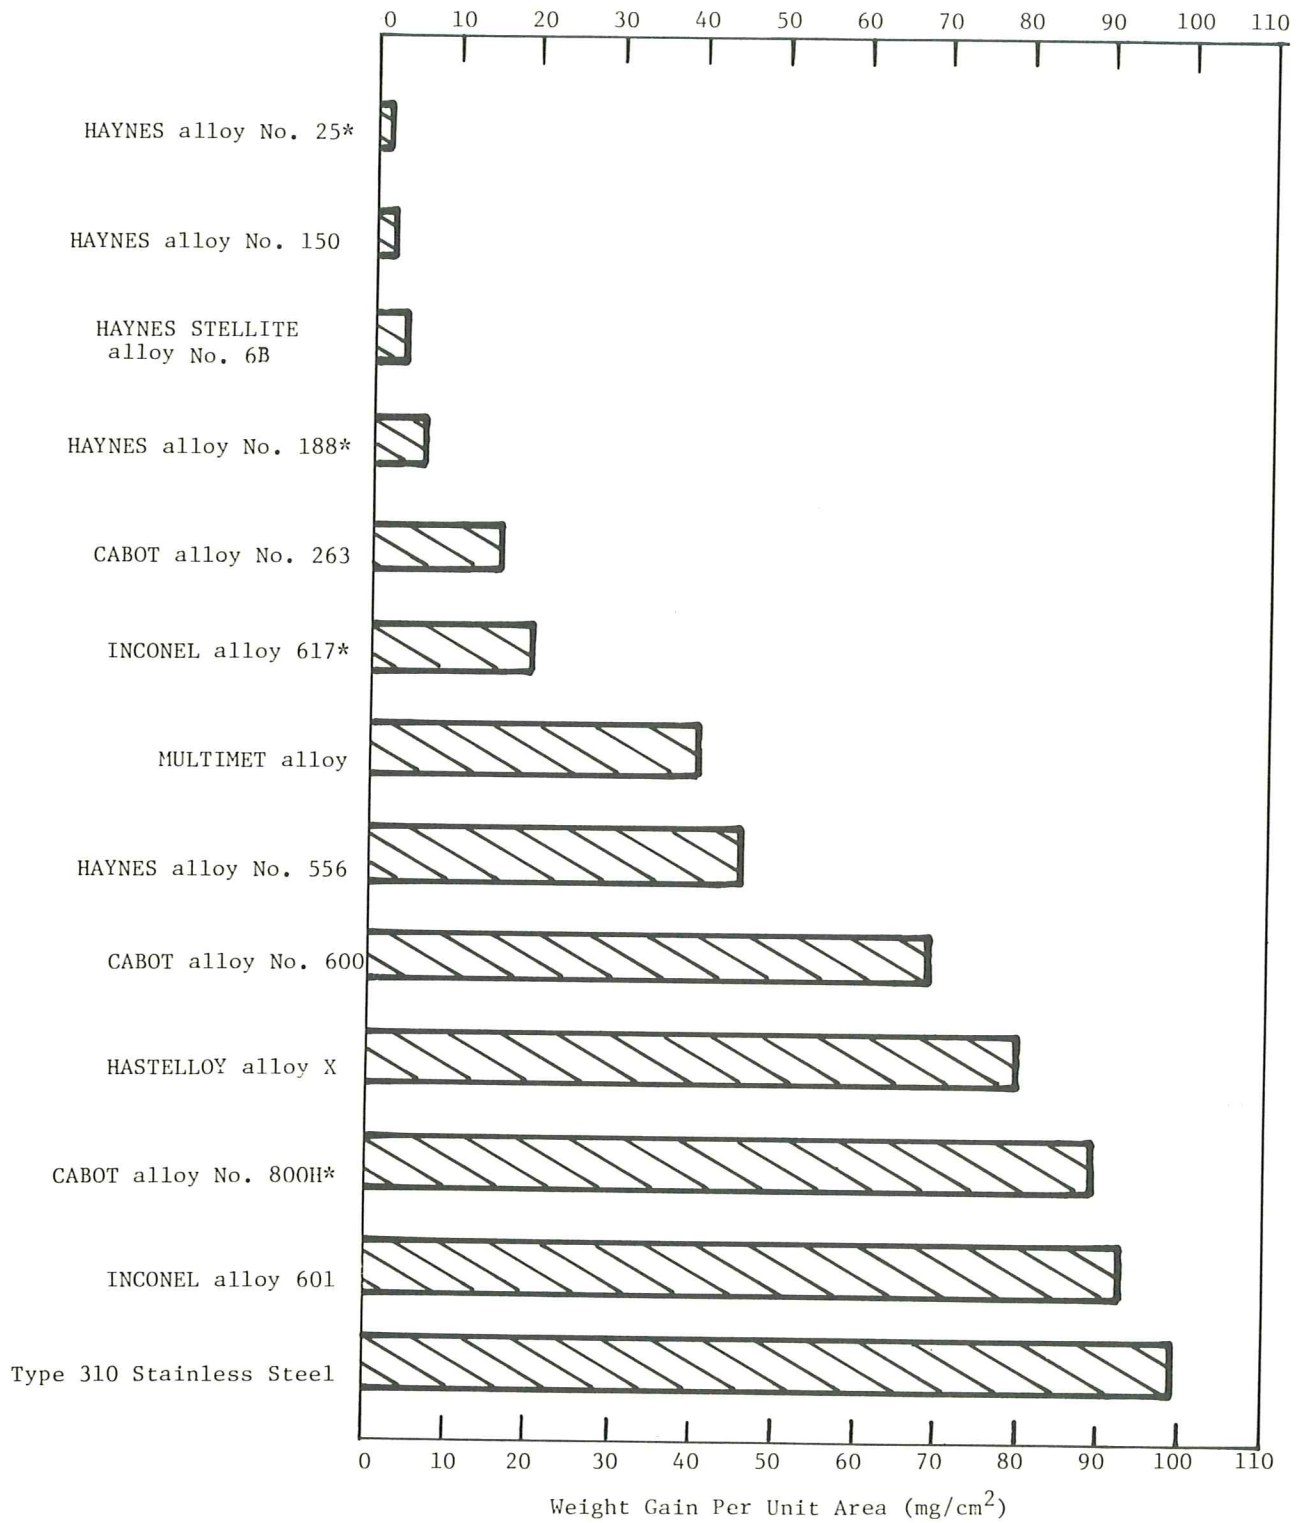
FIG. 11 RESULTS OF SULFIDATION TESTS CONDUCTED AT 871°C (1600°F) FOR 215 HR (*AVERAGE OF MORE THAN ONE TEST)

Based upon these observations, it was clear that the major characteristic of the service environment related to the cause of failure was overheating combined with sulfidation/oxidation. Laboratory sulfidation-resistance tests were conducted at 1600°F (871°C) for 215 hr in a gas mixture consisting of 5 percent H₂-5 percent CO-1 percent CO₂-0.15 percent H₂S-0.1 percent H₂O-Balance Ar (by volume percent). Results are presented in Fig. 11.

Considering these results, and the results of tests similar to those presented in Table 3, HAYNES alloy No. 188 was recommended as an alternate material of construction in view of its excellent combined resistance to both sulfidation and oxidation, its ready fabricability, and the small degree of added over-temperature capability afforded to cobalt-base alloys over lower melting point nickel-base alloys.
